# UPDATE Technical Bulletin

## UPDATE – 90H2 Instrument Cluster (NVLW) – U.S. ONLY

UPDATE 90H2 Instrument Cluster (NVLW)

Model(s)	Year	Engine Code	Trans. Code	From	To
Jetta Sedan	2012 - 2013	All	All	3VW__AJ_CM033700	3VW__AJ_DM386273

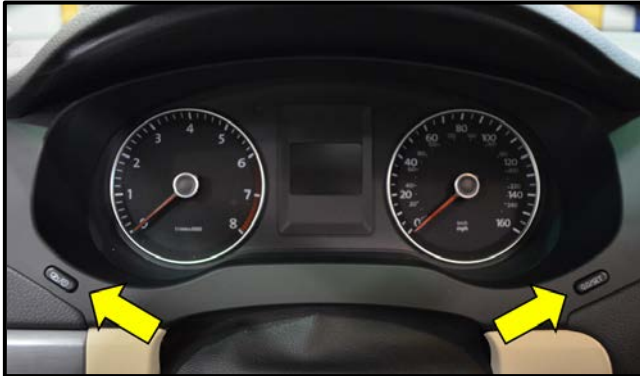
- ⇐ Check for proper operation of each instrument cluster button <arrows>.
- If both buttons operate properly, WORK COMPLETE.
- If one or both buttons do not operate properly, CONTINUE WORK PROCEDURE.
