SUBJECT

Power Reduction, FC 2A82 Intake VANOS and/or FC 2A87 Exhaust VANOS Camshaft Faults are Stored in DME

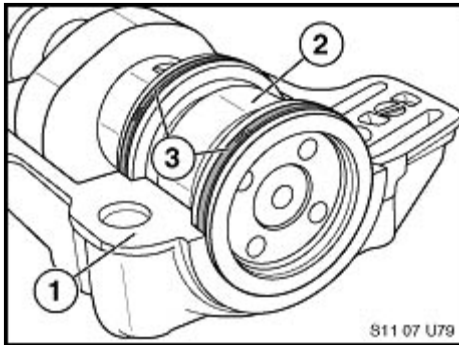
1. Camshaft bearing ledge

2. Intake camshaft
3. Hook ring seals

Note the deep grooves worn into the camshaft bearing ledge by the camshaft hook ring seals. The camshaft bearing ledge is worn.

If the oil filter cap insert is found to be missing, then the entire oil filter housing cap must be replaced (refer to the EPC). If excessive wear to the camshaft bearing ledge is found, it is only necessary to replace the camshaft hook ring seals and the affected camshaft bearing ledge.
