Service Action Circular

Code: 97R7

**Subject: 2006-2009 Passat and Passat Wagon 3.6L Vehicles and
2009 CC/Passat CC 3.6L Vehicles
Inspect, and If Necessary, Replace Positive Battery Cable**

Vehicles affected by this action may have a positive battery cable that may corrode and, in rare cases, break. If this happens, the power supply may be disrupted and the vehicle cannot be started. This action does not apply if the 97P4/Y5 RVU has already been done.

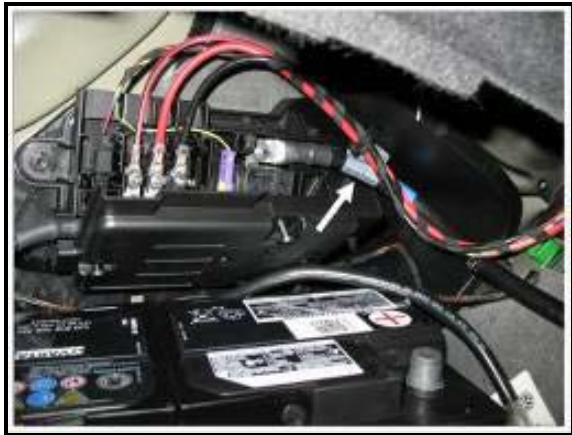
Section A – Check Part Number

**Note:** Because of the difference in the clip positioning points, different positive battery cables are needed for the vehicles

It is important to check the part number of the existing cable to determine which replacement cable is needed

- Unclip battery service cover on side trim
- ⇐ Check part number on the sticker -arrow-
- If part number is 3C0 971 227, then part number 3C0 971 227C must be installed
- If part number is 3C0 971 227A, then part number 3C0 971 227B must be installed
- If correct part number is currently installed, positive battery cable is not one that needs to be replaced, **WORK IS COMPLETE; otherwise, continue to Section B**

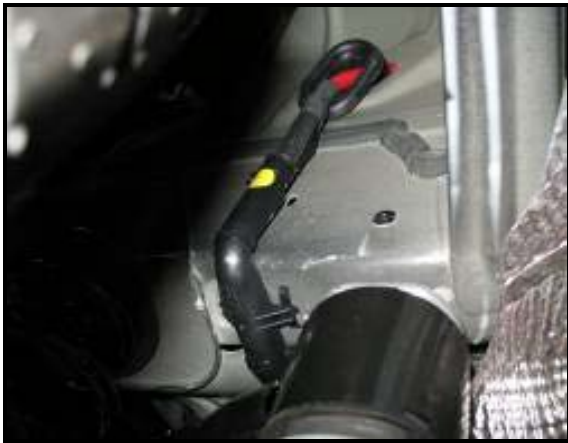
WARNING!

Make sure the fiberglass-reinforced area -arrow- does not get damaged

- Carefully route the new positive battery cable via the rear axle

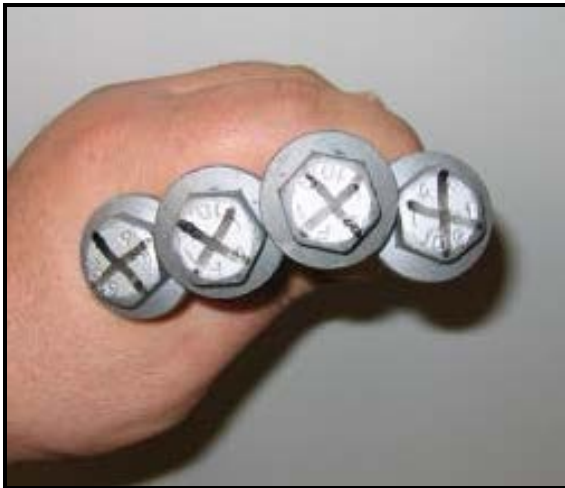
⚠ Note: Contrary to the specifications in the repair manual, the bolts on the subframe and fuel tank **can be reused** in this action

Reuse of these bolts is only permitted for Service Action Campaign 97R7!

⚠ Note: Bolts marked with an "X" indicates that they have been reused one time and should not be reused again

- ⇐ Use a permanent marker or paint pen to mark the subframe bolts with an "X", as pictured
