Applies To: **2011 CR-V** – From VIN 5J6RE3...BL025265 thru 5J6RE3...BL025953  
– From VIN 5J6RE4...BL050299 thru 5J6RE4...BL051818

**May 4, 2011**

## Product Update: Water Leak In the Left Rear Wheelwell

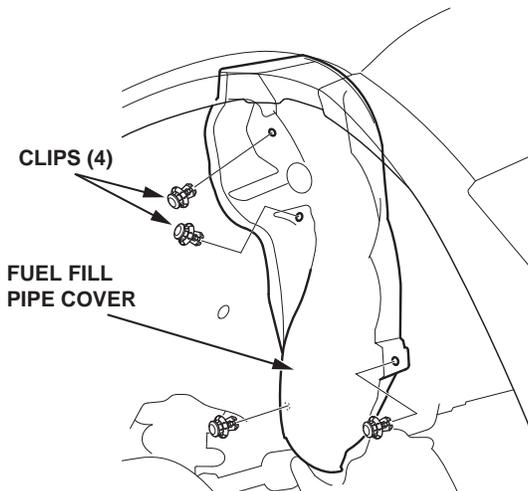
The left rear wheelwell area does not have enough seam sealer. This may allow water to leak into the interior under the rear seat.

3. Using a utility knife, cut parallel along the upper seam to remove the excess bead of sealer. Then clean both areas with lacquer thinner to remove any residue.

NOTE: If the wheelwell metal is cut into when trimming the seam sealer, you must apply a spot primer before resealing.
