# Service Bulletin No. 374

| MODEL<br><b>E / J Series Coaches</b> | TYPE<br><b>Field Change Program</b> | SECTION/GROUP<br><b>6 – Cooling</b> | DATE<br><b>Jan. 13, 2012</b> |
| SUBJECT<br><b>LINNIG FAN CLUTCH COOLING RING</b> | | | |

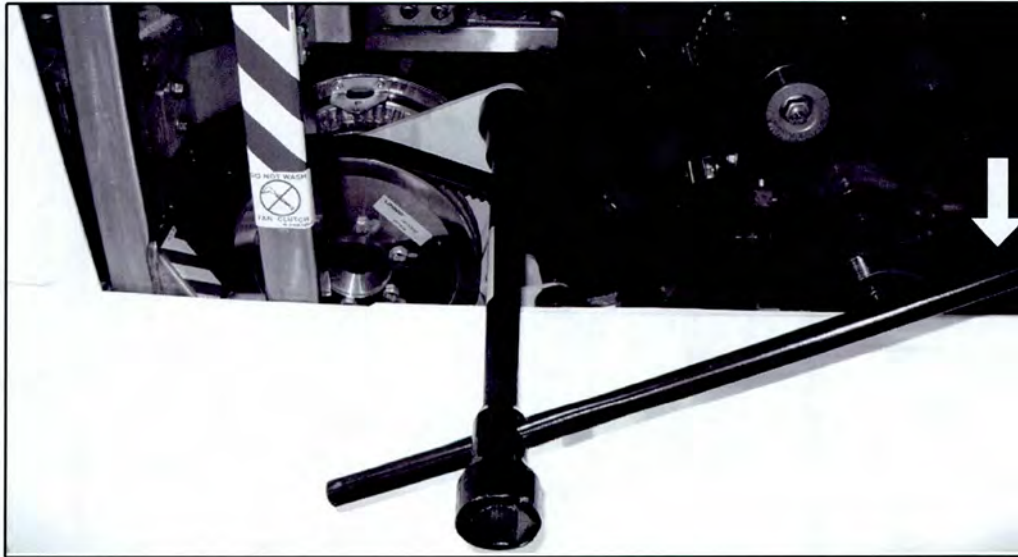
Figure 1.

1. For E / J model coaches prior to 65013, turn the main battery disconnect switch to the OFF position. For E / J model coaches effective with 65013, activate the disconnect feature of the main battery disconnect ( MDS ) system by pressing ( for one second only ) the momentary toggle switch on the MDS module to OFF. An audible click can be heard from the main solenoids in the MDS module. Position the rotary switch to the DOWN ( OFF ) position.
2. Chock both sides of the tires.
3. Open the engine door.
4. Locate the fan clutch ( refer to Figure 1 ).

5. Using the wheel wrench and handle in the drag link compartment, apply controlled downward force on the fan clutch assembly to remove the belt from the fan clutch ( refer to Figure 1 ).
