**SUBJECT: 2009 Mazda6 Advanced Keyless Entry Door Handle Request Switch
Special Service Program (SSP) 89**

Mazda Motor Corporation has decided to conduct a Special Service Program (SSP) on certain 2009 Mazda6 vehicles equipped with Advanced Keyless Entry and produced from February 4, 2008 through February 27, 2009.

2009 Mazda6 Advanced Keyless Entry Door Handle Request Switch SSP89

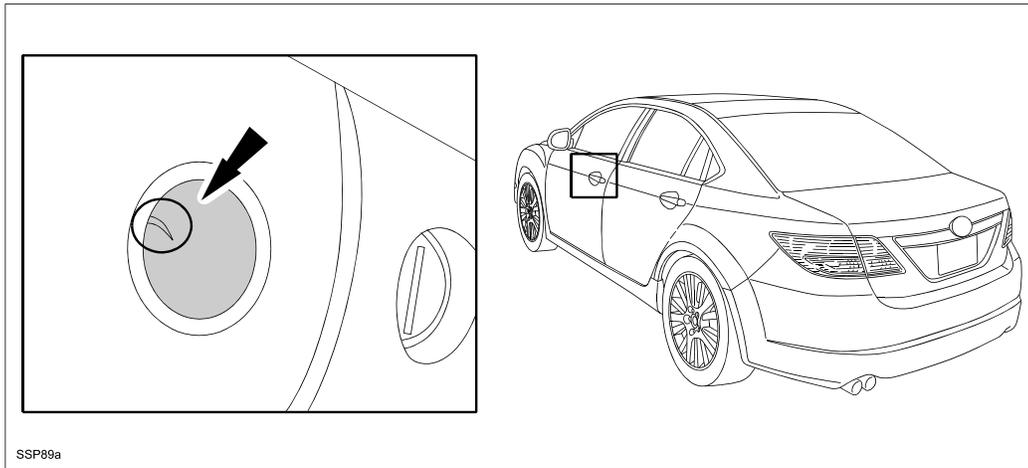
SSP89a

Some vehicles may experience water entry through a crack in front door handle request switch. This condition may result in the keyless unit intermittently freezing.

- ABS warning light, DSC indicator light, DSC OFF indicator light and keyless indicator light (red) suddenly illuminate while driving.
- Information display and navigation display (if equipped) are temporarily blacked-out.
- Unable to start / stop the engine with the push button start.

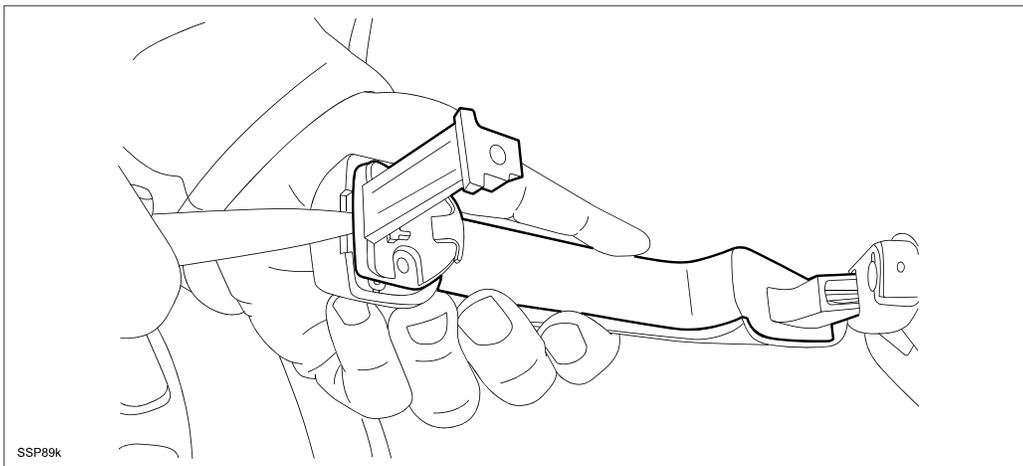
13. Remove the rubber button and closely inspect for cracks. If cracks are found, closely inspect the switch (B) and switch cavity (A) for signs of corrosion or moisture.

12. Using the fiber stick carefully pry the colored cover off of the door handle.

NOTE: The cover is hooked in at the harness end, so start at the button end and work your way back.
