Program Bulletin

CUSTOMER SATISFACTION PROGRAM

SUBJECT: Enhancements for Side Impact Pole Performance

MODELS: 2011-2012 Chevrolet Volt

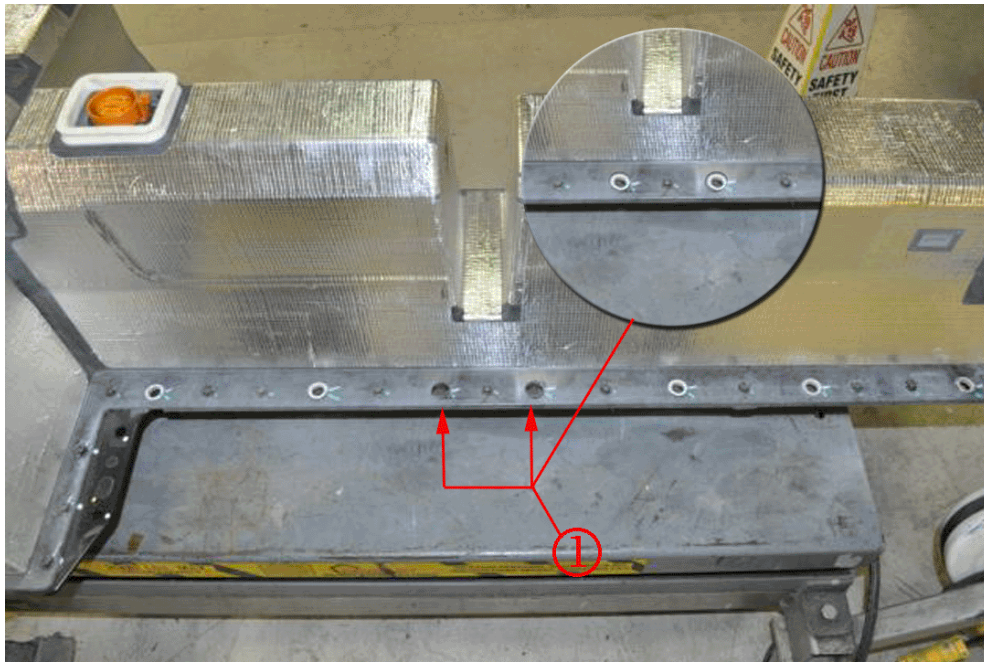
2756830

Note: Butyl should only be applied in the chamfer (red face) of the crush limiter. Refer to illustration. Butyl should not be present in the metal-to-metal joint between RESS cover, reinforcement plate and longitudinal rails.

3. Apply a butyl-based sealer such as 3M Ribbon Sealer 08612 or 3M Strip-Caulk 08578 (or equivalent) on the chamfer of the new aluminum crush limiters.
