**SB-10043900-3421**

Reference SSM56077

Models X250 / XF

Title Front Pilot Lamp (Side Light) replacement

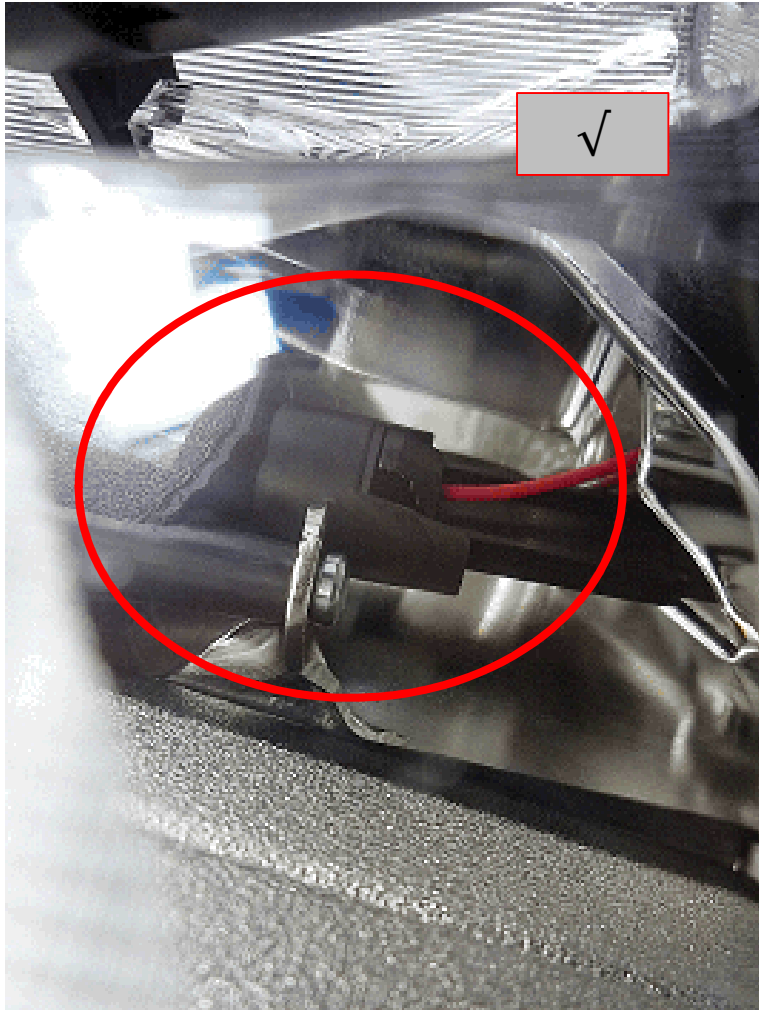
Front headlamp reflector and or bulb holder "Melted".

Miss fitting of the bulb holder after bulb replacement.

Content When replacing the pilot lamp (side lamp) bulb special care must be taken to make sure that the bulb holder is inserted into the reflector housing correctly. The bulb holder should be inserted / push into place securely until a firm click can be felt & heard. If the bulb holder is not fully inserted it becomes loose, the bulb then comes into contact with the reflector housing melting both the bulb holder and reflector. This results in the need for a replacement lamp. Please see attachment for illustrations of a correctly fitted bulb holder and a melted lamp and bulb holder as a consequence of misfitting the bulb holder.
