EL12-016

April 27, 2012

## IGNITION SWITCH (PUSH BUTTON) WILL NOT RESPOND

**APPLIED VEHICLES:** 2010 – 2012 G37 Coupe (CV36)

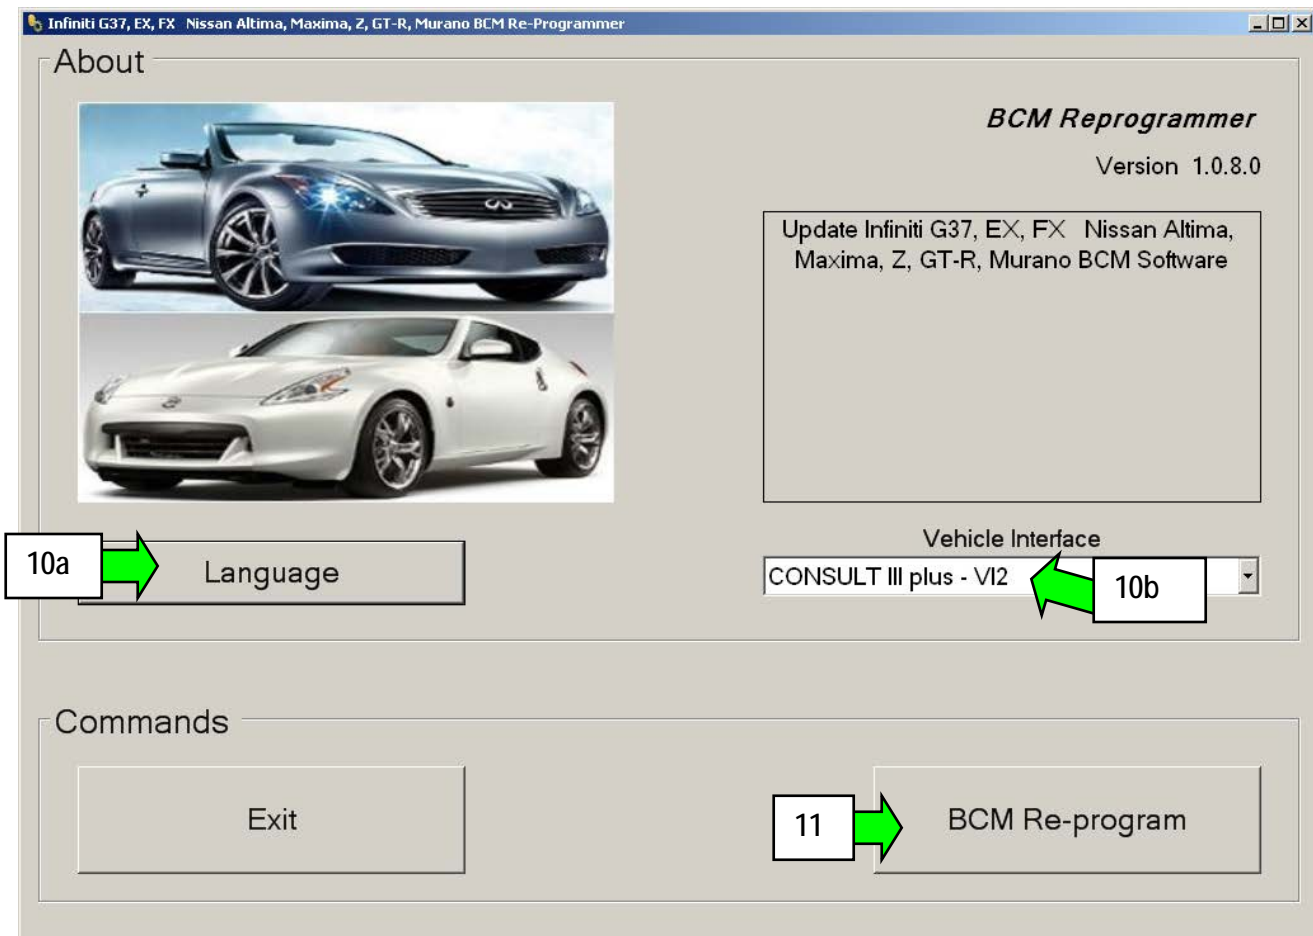
Figure 1

10. Make selections on the main screen (see Figure 1).

11. Select **BCM Re-program**

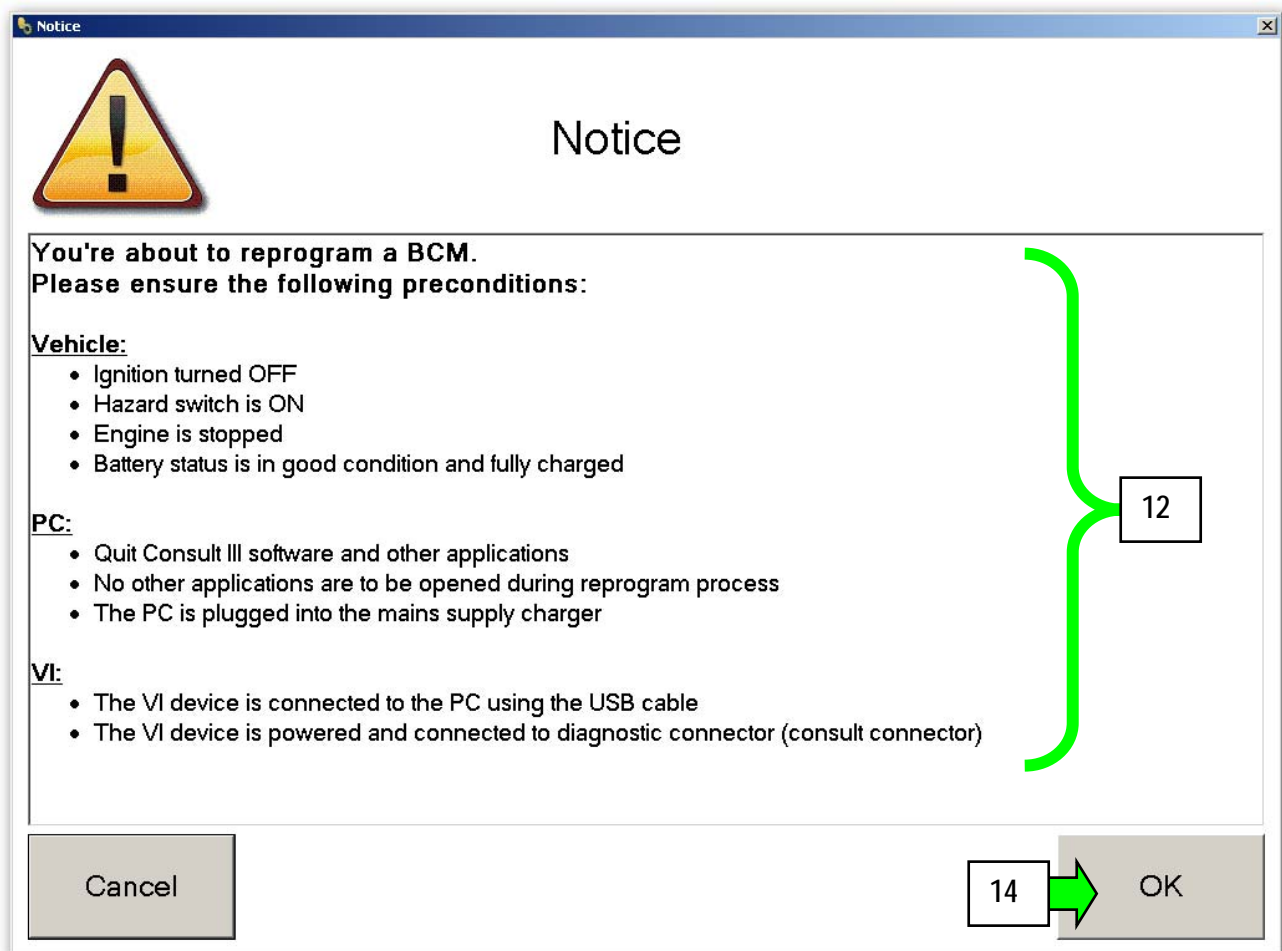
Figure 2

12. Make sure each of the preconditions listed on the screen have been met (see Figure 2).

14. Select **OK** – BCM reprogramming will start.

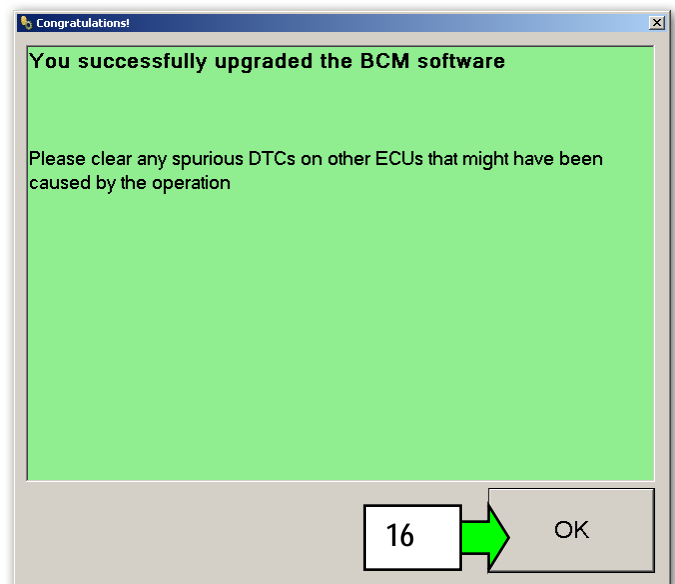
**NOTE:** When BCM reprogramming is complete the screen in Figure 5 displays and the hazard flashers will start flashing.

15. Turn OFF the hazard lights.

16. Select **OK**.

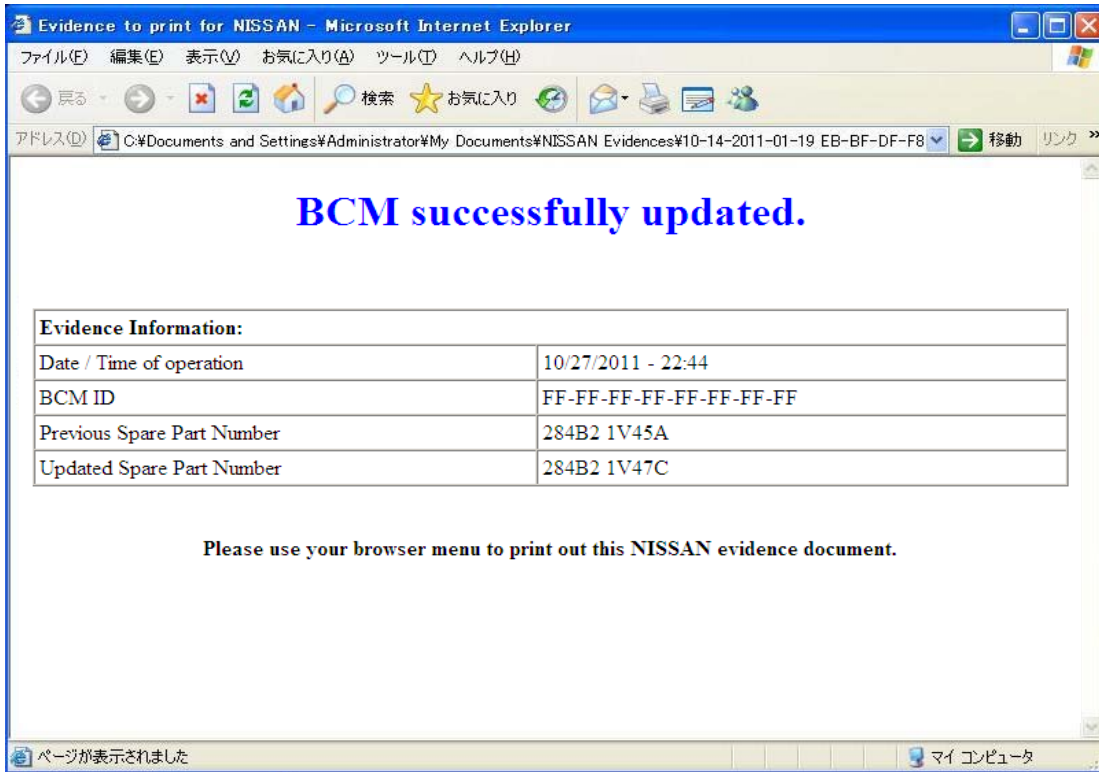
**NOTE:** When OK is selected, Internet Explorer will automatically launch and the screen in Figure 6 (shown on the next page) will display.

17. Print the Internet Explorer screen shown in Figure 6 and attach a copy to the repair order.
