RECALL CAMPAIGN BULLETIN

NTB12-040c

VOLUNTARY EMISSIONS RECALL CAMPAIGN 2010 ALTIMA SEDAN AND COUPE ECM REPROGRAM AND MANIFOLD CATALYST

CAMPAIGN ID #: PC129

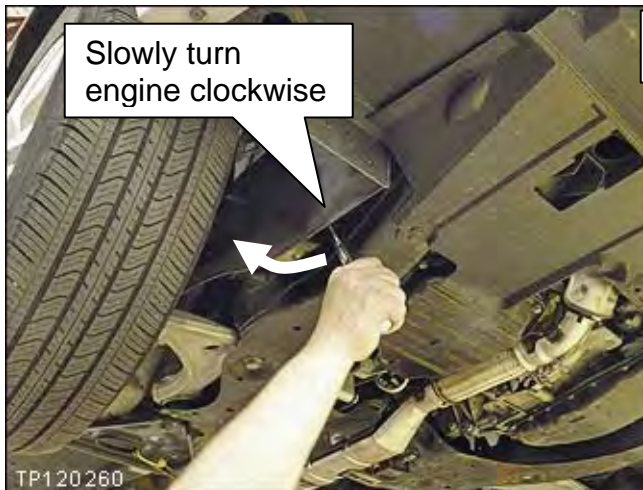
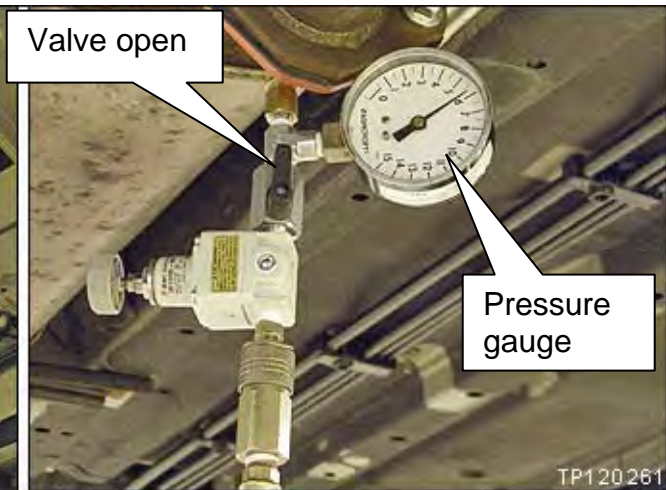
Figure P9a

- a. Watch the pressure gauge while slowly turning the engine (see Figures P9a and P9b).
 - Turn the engine clockwise (as you face the front of the engine).
- b. When the pressure gauge is reading at the highest point (most PSI) stop turning the engine.
 - Highest pressure will be between 5 and 6 PSI.

13. Set the valve on special tool J-50976 to the open position (see Figure P9b).
14. Attach a 19 mm socket with handle to the front crank pulley (see Figure P9a).
15. Position the engine crank shaft at the point of the highest pressure on the gauge as follows:
