RECALL CAMPAIGN BULLETIN

NTB12-040b

VOLUNTARY EMISSIONS RECALL CAMPAIGN 2010 ALTIMA SEDAN AND COUPE ECM REPROGRAM AND MANIFOLD CATALYST

CAMPAIGN ID #: PC129

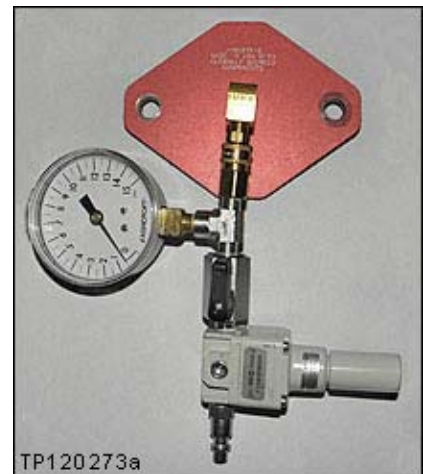
Figure A

- When using this tool, do not block the regulator bleed hole with a finger or any other item.
- Blocking the regulator bleed hole may damage the tool.
