RECALL CAMPAIGN BULLETIN

NTB12-040a

VOLUNTARY EMISSIONS RECALL CAMPAIGN 2010 ALTIMA SEDAN AND COUPE ECM REPROGRAM AND MANIFOLD CATALYST

CAMPAIGN ID #: PC129

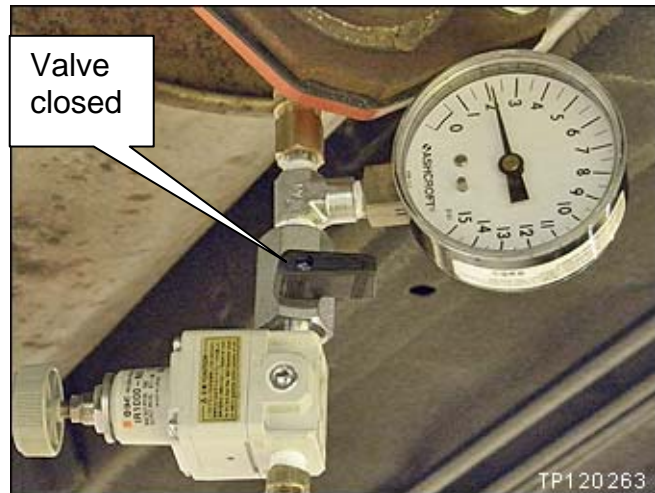
Figure P10

NG: Pressure is below 2 psi:

- Front tube or manifold has a leak.
- By feel and sound, locate the leak.
- Replace the leaking part (front exhaust tube and/or exhaust manifold).

- For all vehicles with **more than 50,000 miles**, replace the exhaust manifold even if it does not have a leak.
- Replacement of the exhaust manifold includes removal of the exhaust manifold stay.
- Refer to page 11 for Front Exhaust Tube Replacement and/or page 13 for Exhaust Manifold Replacement.

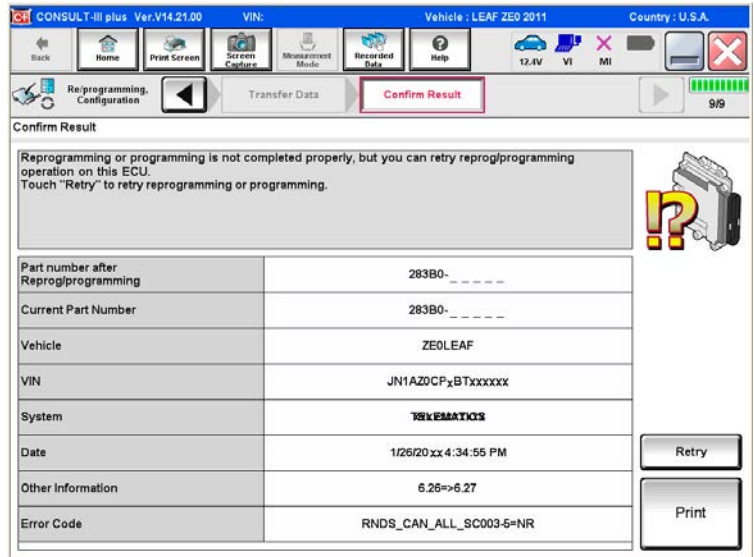
Figure 5

If reprogramming does not complete and the “!?” symbol displays as shown in Figure 5:

- Check battery voltage (12.0 – 15.5V).
- Ignition is ON, Ready Mode is OFF.
- External Bluetooth® devices are OFF.
- All electrical loads are OFF.
- **Select Retry and follow the on screen instructions.**

NOTE: Retry may not go through on first attempt and can be selected more than once.
