AT12-003

ITB12-027

May 15, 2012

## 2010 - 2011 G37; SHIFT RESPONSIVENESS ISSUES

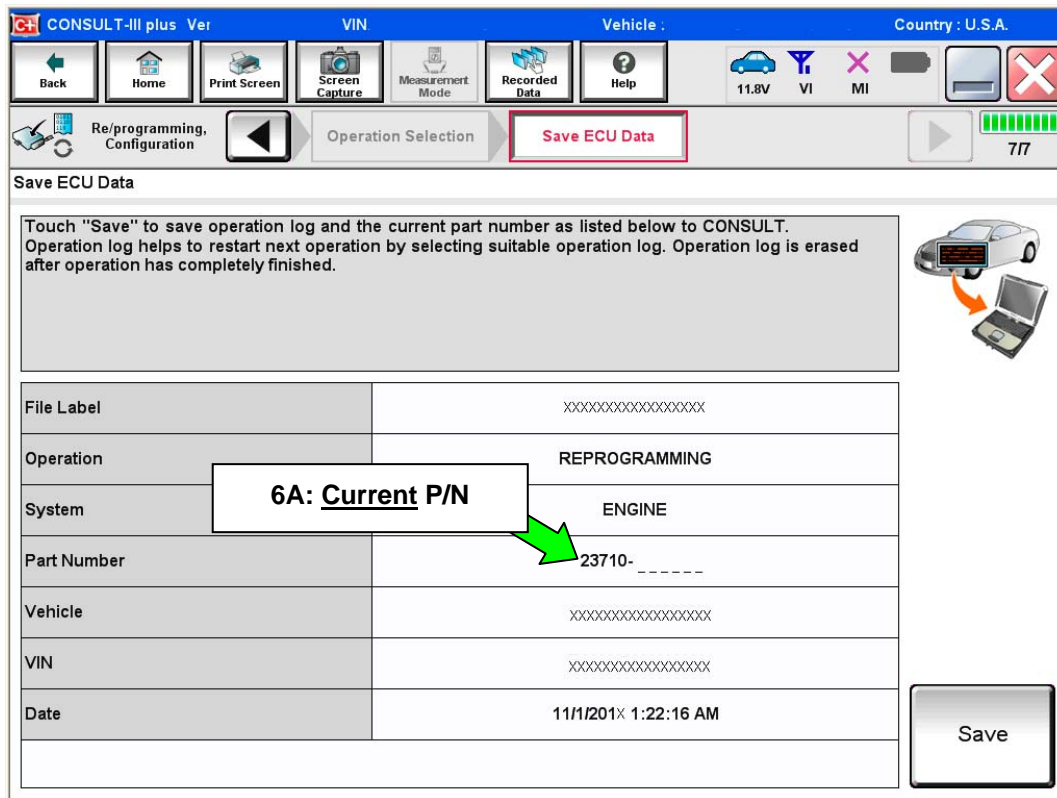
Figure 2

6. When you get to the screen shown in Figure 2, confirm this bulletin applies as follows:
- A. Find the ECM or TCM **Part Number** and write it on the repair order.

**NOTE:** This is the current ECM or TCM Part Number (P/N).

- B. Compare the P/N you wrote down to the numbers in the **Current ECM or TCM Part Number** column in **Table A** on next page.
- If there is a match, this bulletin applies. Continue with the reprogramming procedure.
  - If there is not a match, reprogramming does not apply. Make sure to check both ECM and TCM for a match.

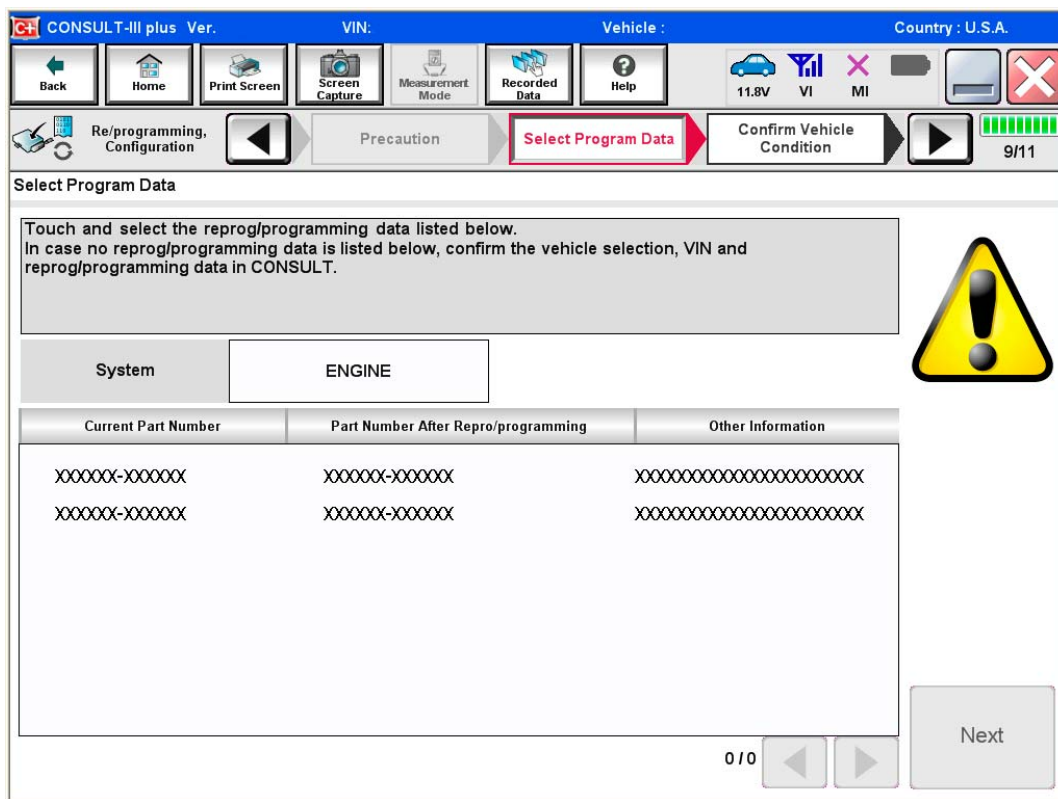
- In some cases, more than one new P/N for reprogramming is available.
  - In this case, the screen in Figure 3 displays.
  - Select and use the reprogramming option that **does not** have the message "Caution! Use ONLY with ITBXX-XXX".
- If you get this screen and it is **blank** (no reprogramming listed), it means there is no reprogramming available for this vehicle.

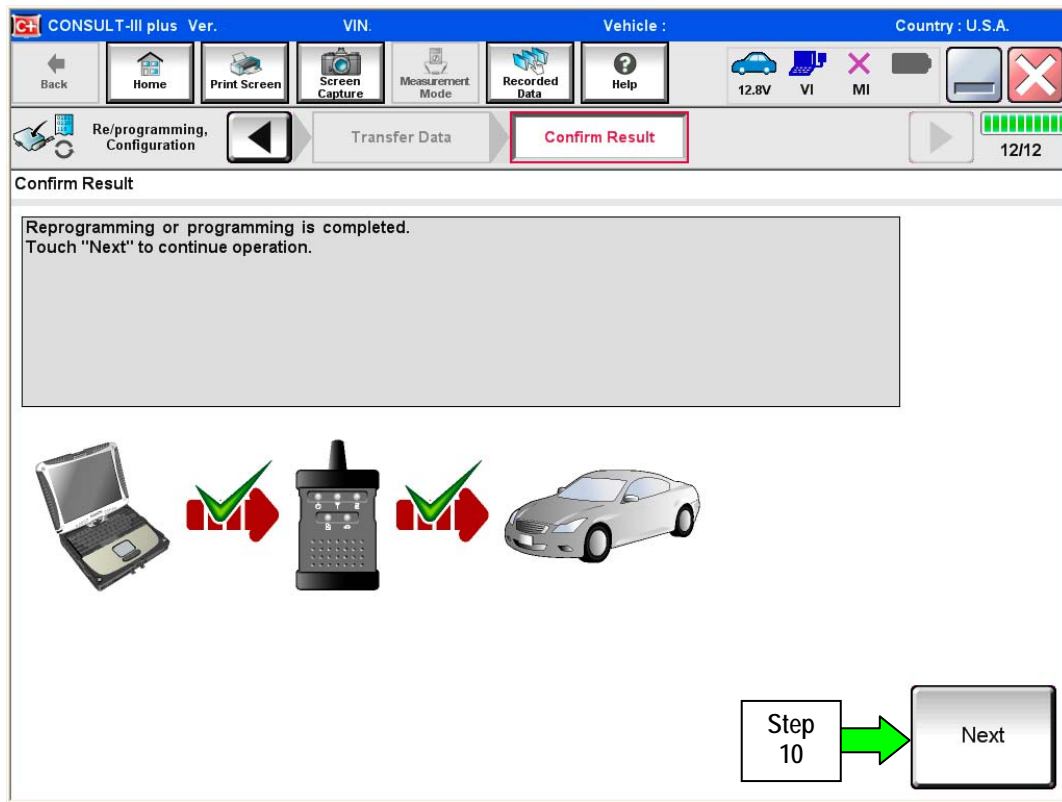
8. When the screen in Figure 4 displays, reprogramming is complete.

**NOTE:** If the screen in Figure 4 does not display (reprogramming does not complete), refer to the information on the next page.

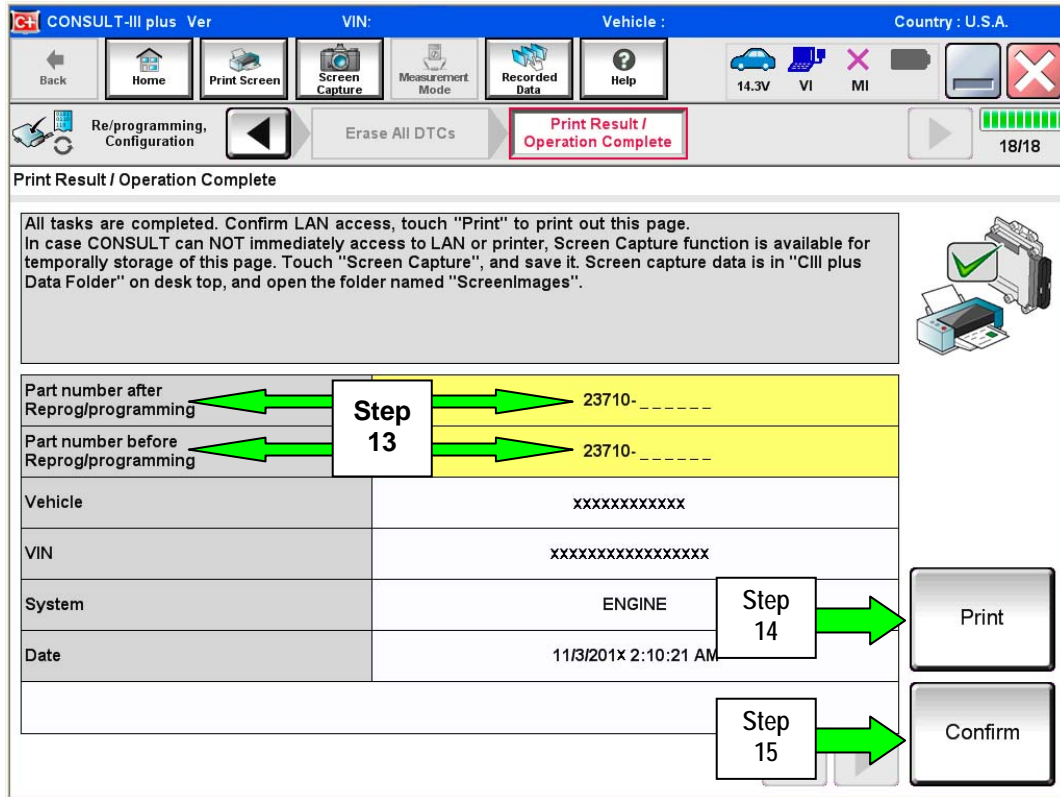
Figure 7

12. When the entire reprogramming process is complete, the screen in Figure 5 will display.
13. Verify the before and after part numbers are different.
14. Print a copy of this screen (Figure 7) and attach it to the repair order for warranty documentation.
15. Select **Confirm**.

16. Make sure you have performed both ECM and TCM reprogramming.
17. Close C-III plus.
18. Turn the ignition OFF.
19. Disconnect the plus VI from the vehicle.
20. Test drive the vehicle and make sure it operates correctly and the MIL is OFF.
  - If the MIL comes ON, go back to ASIST for further diagnostic information.
  - Diagnosis and repairs beyond ECM or TCM reprogramming are not covered by this bulletin.
