### Connector Pin, Replacement

VN, VHD, VT, VAH  
D11, D13, D16

## FSB 255-023, Connector Pin, Replacement

(April 2012)

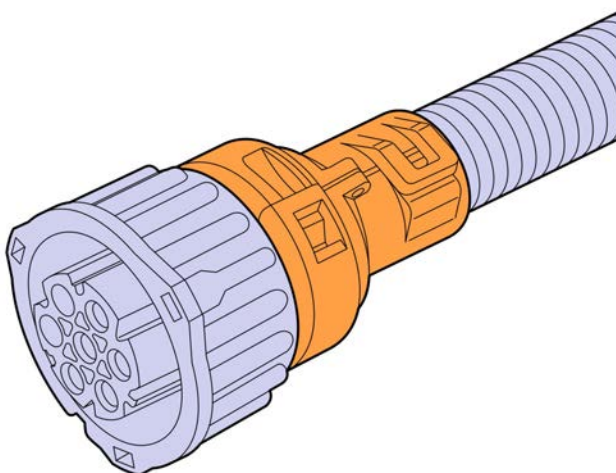
W2072543

**Note:** The engine VGT Actuator harness connector is shown for reference only. The procedure is the same for the TSS harness connectors.

- 5 Remove the conduit clamps from both harness sections.

- 6 Using extraction tool 9808646 or 9809774, remove the defective pins from the connectors.
