Technical Bulletin

Division: Automotive Category: Technical Section Title: Restraints TSB No. TS 02 05222

SUBJECT:	SPECIAL COVERAGE EXTENSION FOR A SPECIFIC "AIRBAG"
	WARNING LIGHT ILLUMINATION (DTC B1312 ONLY).
MODEL(S):	SX4 (RW420)
YEAR:	2007~2011

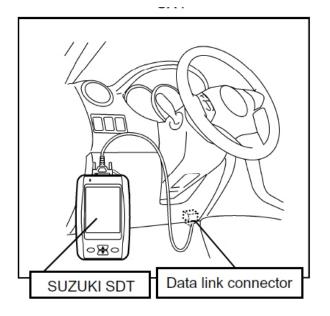
- 9. After completing the replacement, erase DTC using scan tool.
- 10. After clearing the "AIRBAG" DTC(s), confirm the following:
 - ✓ "AIRBAG" warning light does not remain illuminated after flashing.

- Passenger seat belt reminder light does not illuminate when turning the ignition switch to the "ON" position.
- 11. The repair is complete. Return the vehicle to the customer.

- Replace front passenger seat cushion assembly with new one (Please refer to the EPC and appropriate Suzuki Service Manual for replacement of the lower seat cushion on the right front passenger seat only).
