Engine Variable Geometry Turbocharger  
(VGT) Actuator Connector Pin, Replacement

VAH, VHD, VN, VT  
D11, D13, D16

**FSB 255-024, Engine Variable Geometry  
Turbocharger (VGT) Actuator Connector Pin,  
Replacement**

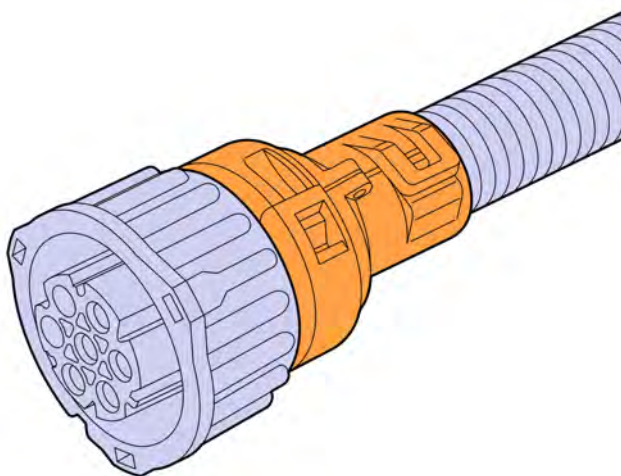
W2072543

**Note:** The engine VGT actuator harness connector is shown for reference only.

- 5 Remove the conduit clamps from both harness sections.

- 6 Using extraction tool 9808646 or 9809774, remove the defective pins from the connectors.
