RECALL CAMPAIGN BULLETIN

ITB11-039e
 June 8, 2012

VOLUNTARY SAFETY RECALL CAMPAIGN 1997-2003 QX4 IN SALT STATES FRONT STRUT HOUSING CORROSION

CAMPAIGN ID #: R1109 **NHTSA** #: 11V-244

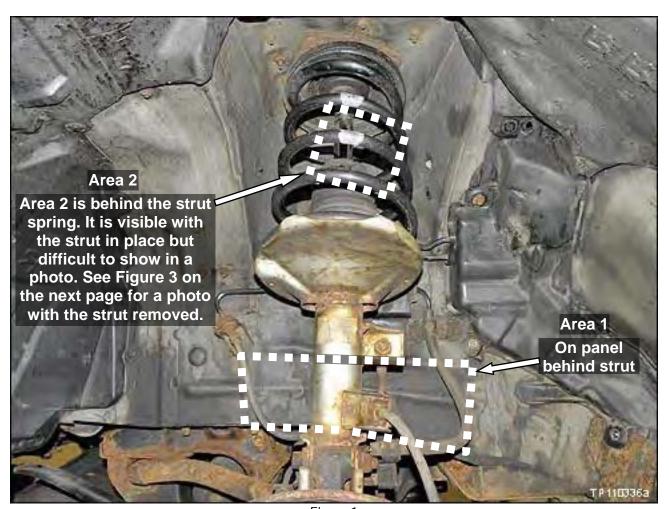
Figure 1

3. Inspect for corrosion on the driver side AND passenger side in the wheel house <u>Area 1</u> and strut housing <u>Area 2</u> (see Figures 1, 2, 3, and 4).

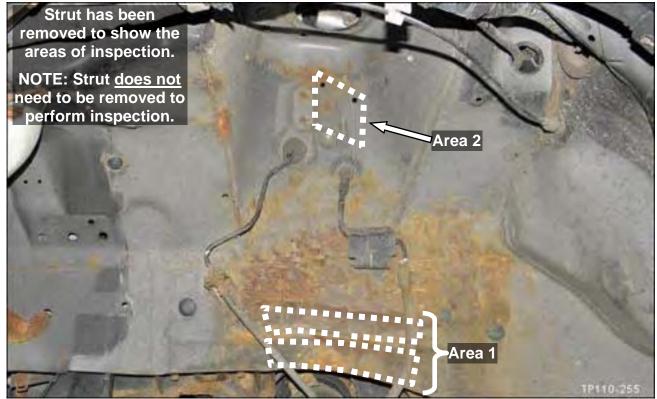
Figure 2

This example photo shows the inspection areas in relation to the repair bracket installation.

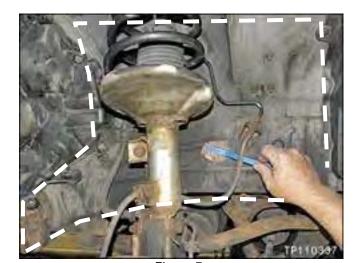
Figure 7

For driver side AND passenger side - no visible rust or only surface rust

- Plastic covers (fender protectors) in the wheel house area do not need to be removed.
- Photos in this section are of the passenger side, driver side is similar.
- For 4WD vehicles: If the drive shaft boot is ripped, it should be covered to prevent debris from entering the drive shaft joint.
- 1. Use a wire brush to remove loose rust in the area shown with dashed line.

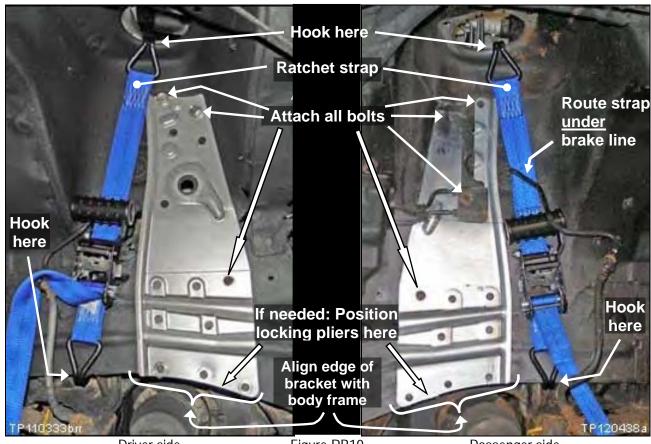
Driver side Figure RB10 Passenger side

15. Only if the strut housing panel is separated:

- a. Attach the ratchet strap as shown in Figure RB10.
- b. Use the ratchet strap to pull the strut housing panel down until the existing threaded hole(s) is aligned with the matching hole in the repair bracket (see Figure RB10).
- 16. Install all bolts as shown in Figure RB10, and make them finger tight.
- 17. Align the bottom edge of the repair bracket with the edge of the body frame.
 - The bracket will have some movement in all directions. Move it (align it) the best possible.
- 18. Once the bottom edge is aligned, securely tighten all bolts (see Figure RB10).
 - At this time, a pair of locking pliers or equivalent tool may be used to further support the repair bracket (see Figure RB10).
 - Bolts need to be tight enough to hold the bracket in place while center punching and drilling holes in the next step.

NOTE: Photos for installation of the repair bracket show the ratchet strap being used. In most cases, the strut housing panel will not be separated and the ratchet strap will not be needed.

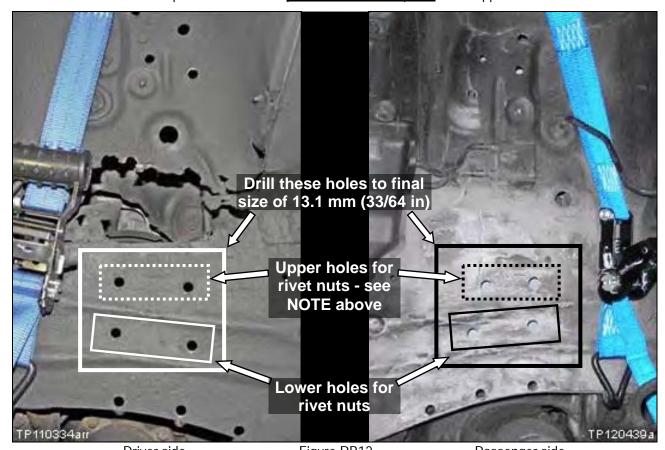
Driver side Figure RB12 Passenger side

If the metal in the area of the lower holes will not support the rivet nuts, then the vehicle is "not repairable": Retain the vehicle at the dealer, supply the customer with a rental car, and Fax a completed Non-Repairable Report to Morley (see page 54).

22. For the 4 holes that will have Rivet Nuts installed, drill final hole size to **13.1 mm** (33/64 in). See Figure RB12.

NOTE: Upper holes – not required: If the metal in the area of the upper holes will not support rivet nuts, continue with the repair. Rivet nuts are preferred but not required in the upper holes.

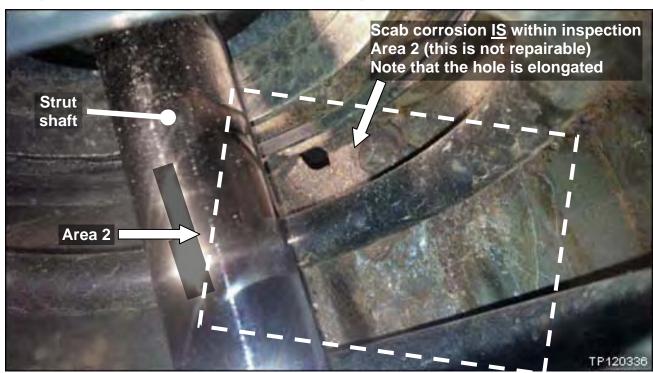
Example (Additional Photo) of Area 2 Scab Corrosion Inspection

Area 2: Look for "scab corrosion" (flaking rust or raised rust) on driver side AND passenger side <u>only in the area outlined above</u>.

If there is scab corrosion (flaking or raised rust) in Area 2, driver side OR passenger side:

- a. Retain the vehicle at the dealer. (The vehicle is not repairable.)
- b. Supply the customer with a rental car.
- c. Fax a completed Non-Repairable Report to Morley (see page 54).
