Engine VGT Actuator and TSS Sensor
Connector, Relocation
CHU, CXU, GU, MRU
MP8

SB-10044335-6505 PI0781, Engine VGT Actuator and TSS Sensor Connector, Relocation

(May 2012)

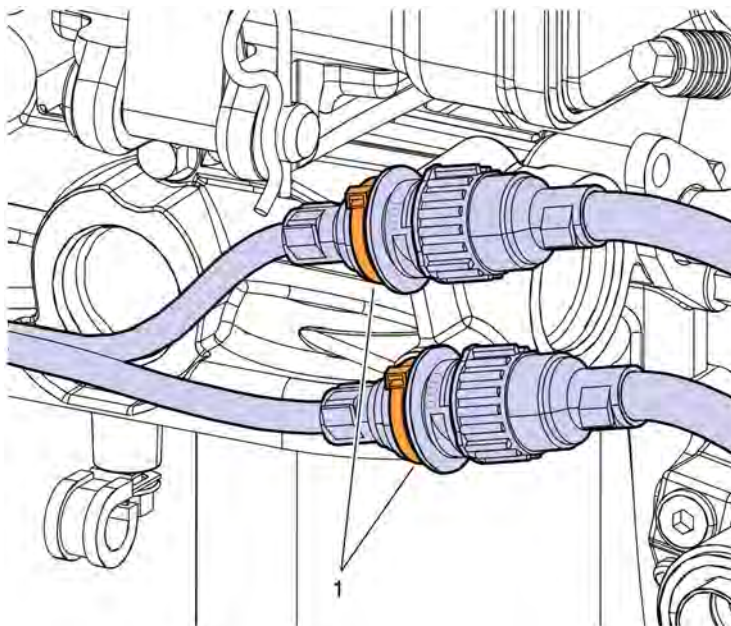
W2072567

A new campaign is available to prevent engine diagnostic trouble codes (DTCs) and missing signal from the Engine Variable Geometry Turbocharger Actuator (Engine VGT Actuator) on MACK MP8 US2010 engines with a Mechanical transmission. This condition is caused by fretting of the connector pins in the engine VGT actuator connector. Relocation of the engine VGT actuator connector and a new mounting arrangement has been developed to eliminate this condition. See the table below for the list of parts required for this campaign.
