Mack Trucks, Inc.
Greensboro, NC USA

Service Program Trucks

Date	Group	No.	Release	Page
6.2012	491	787	02	1(8)

PI0787, Transmission Cooler Line O-Ring

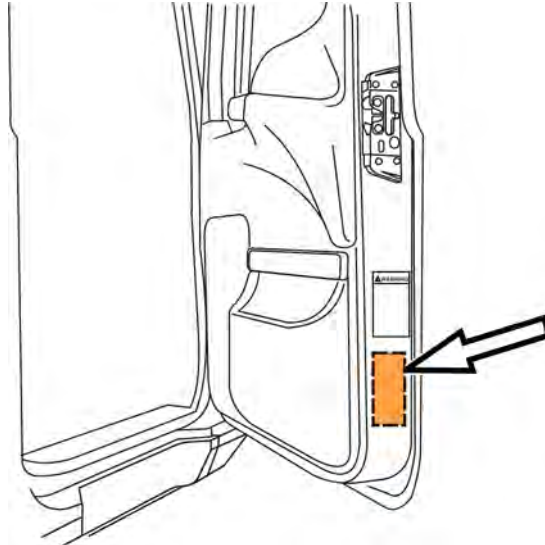
W8034103

Note: To signify that the campaign has been completed, using a permanent-type marker (such as a Sharpie®) to write the campaign number (PI0787) and completion date in the spaces provided on the Campaign Completion label located inside the cab as shown in the illustration below. If a label is not already affixed inside the cab, apply a label (part No. TS897) and supply the information as required. Campaign Completion labels are available in packs of 50 and can be ordered by faxing a completed BR313 to Pacesetters Business Services at 610-264-9465.
