Coronado
Business Class M2
> Cascadia
108SD/114SD

Freightliner
Service Bulletin

General Information

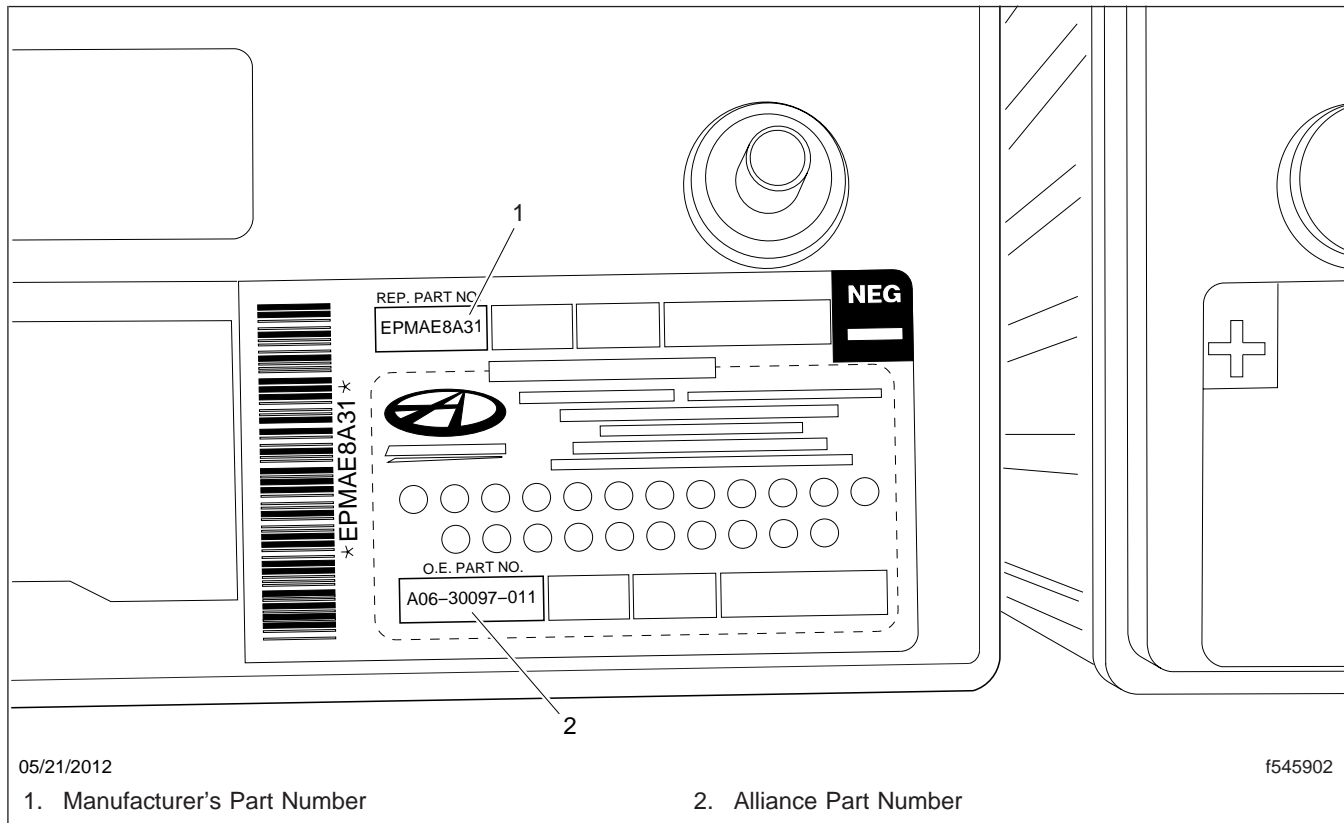
Fig. 3, Battery Label

The manufacturer's battery part number is shown on the top left-hand side of the battery label. See Fig. 3. The full part number of the 8A31 is shown as EPM AE8A31. The Alliance part number (A06-30097-011) can also be used if the manufacturer's part number is worn away or obscured.
