# Technical Service Bulletin

## 94 Headlight Warning on in Cluster (Xenon Plus With or Without Adaptive Light)

94 12 74 2029194/1 April 19, 2012.

Model(s)	Year	VIN Range	Vehicle-Specific Equipment
Audi Q7	2010 – 2012	000001 – 999999	Premium Plus or Prestige Option Packages

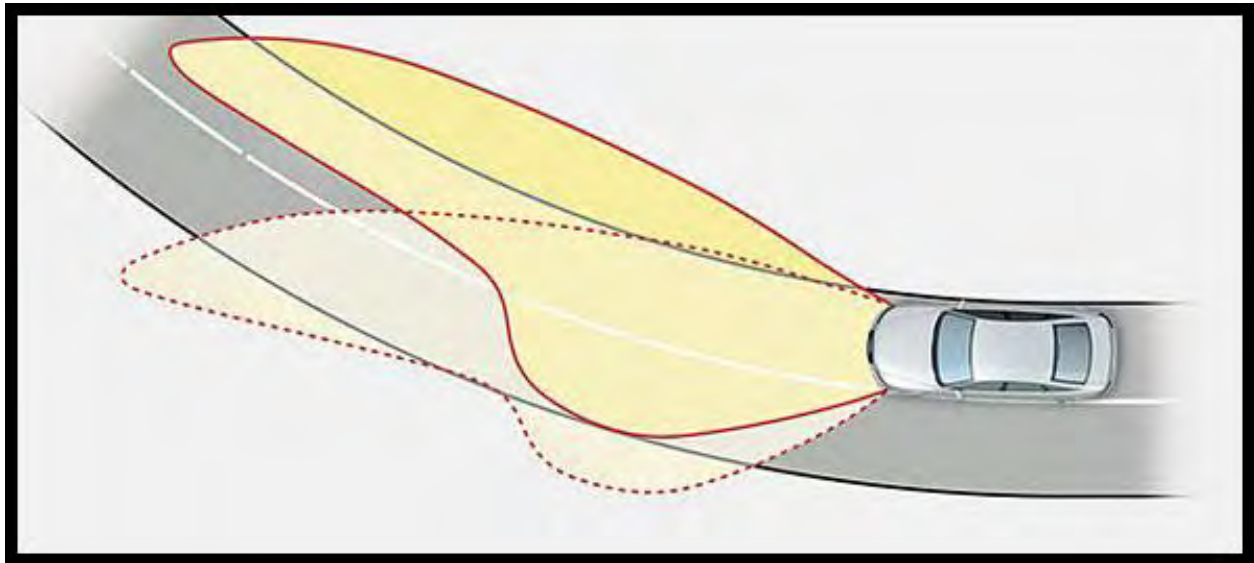
**Figure 5.** Audi Adaptive Lighting illustration showing the maximum 15° curve of the light beam at speeds greater than 6mph.

4. Ensure all the connectors are fully seated and locked. If a loose connector is found, skip step 5 and move to step 6.
5. If no loose connector is found and the issue still persists then the issue, is outside the scope of this TSB and the remaining steps can be skipped. A swap of headlamp components between left and right is the next logical step to narrow down the failed part of the headlamp.
6. Reassemble the headlamp and install it back in to the vehicle.
7. Clear the DTC and retest with low beams activated, high beams activated, and all turn signals activated.
8. If no DTCs return, test the headlamp functionality in the garage or parking lot but also perform a short road test and repeat the actuation of all headlamps functions while at a speed. To test the adaptive light function (if equipped) the vehicle will need to be driven at speed around a corner at a speed greater than 6mph.
