Mack Trucks, Inc.
Greensboro, NC USA

Field Service Bulletin Trucks

Power Take Off (PTO) Output Wire
CHU, CXU, GU, TD

FSB 371-043, Power Take Off (PTO) Output Wire

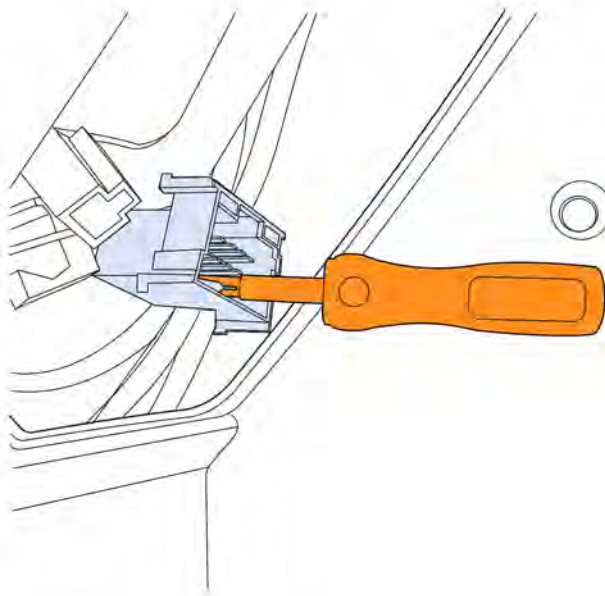
W3073817

Extraction tool 9812475

- 5 Disconnect the black 18 pin connector from the green 18 pin connector.
- 6 Find wire CB7A located in cavity 15 on the black connector. Using extraction tool 9812475 (part of tool kit 8890037) or extraction tool 85131561 (part of tool kit 85131399) to remove the pins as instructed.

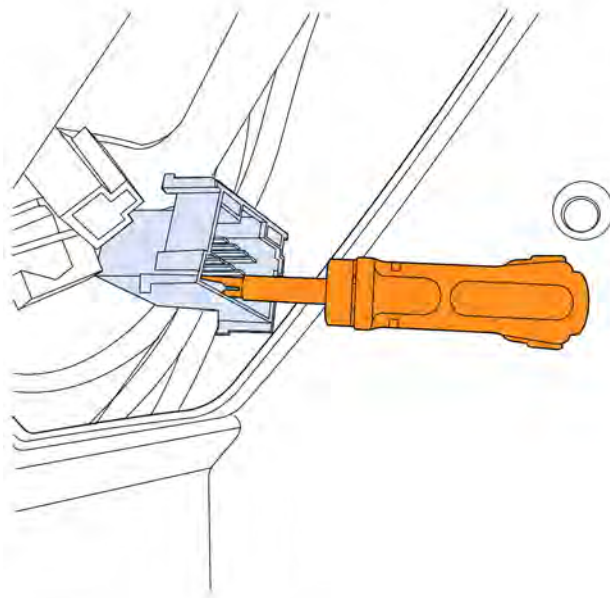
W3075161

Extraction tool 85131561
