DEALER SERVICE ACTION

2013 ALTIMA STEERING COLUMN NUT TORQUE

ID #: PC158

APPLIED VEHICLES: 2013 Nissan Altima

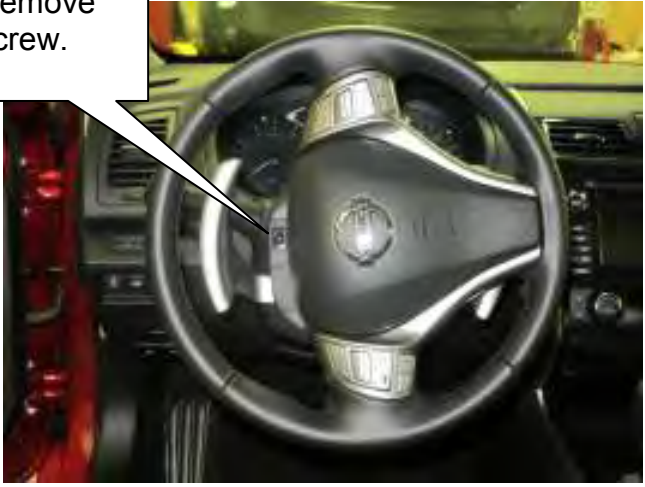
Remove screw.

1. Remove top steering column finisher.
 - Turn steering wheel 90 degrees to the left and remove 1 Phillips screw.
 - Turn steering wheel 90 degrees to the right and remove 1 Phillips screw.

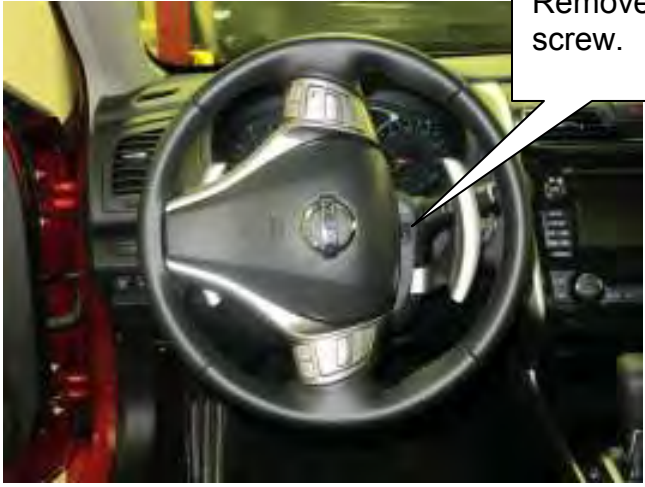
Remove screw.
