# RECALL CAMPAIGN BULLETIN

NTB12-092

## VOLUNTARY EMISSIONS RECALL CAMPAIGN 2009 ALTIMA SEDAN AND COUPE ECM REPROGRAM AND MANIFOLD CATALYST

**CAMPAIGN ID #:** PC130**APPLIED VEHICLE:** 2009 Altima Sedan and Coupe (C/L32)  
with SULEV (California Specification) 2.5 engine

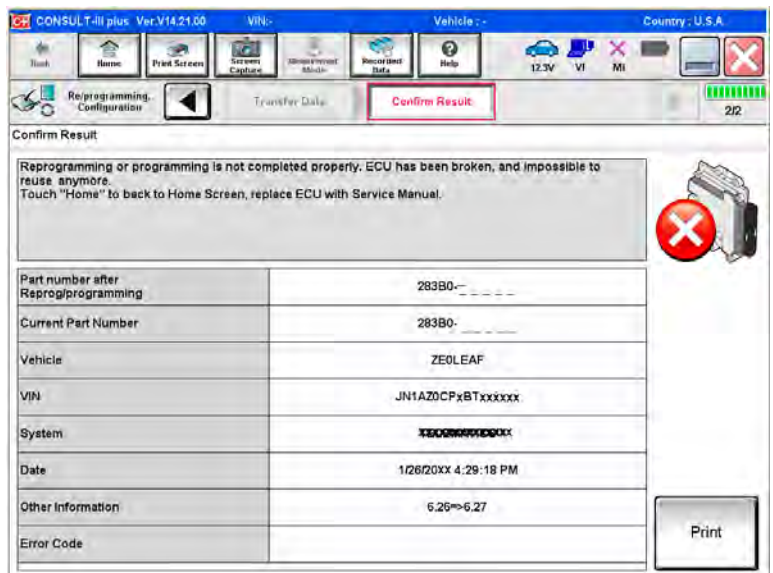
Figure 6

If reprogramming does not complete and the “X” symbol displays as shown in Figure 6:

- Check battery voltage (12.0 – 15.5V).
- CONSULT A/C adapter is plugged in.
- Ignition is ON, Ready Mode is OFF.
- Transmission in Park.
- All C-III plus / plus VI cables are securely connected.
- All C-III plus updates are installed.
- **Select Home, and then restart the reprogram procedure from the beginning.**
