Service Bulletin

Bulletin No.: PI0813

Subject: Driver Airbag Light Flashing and/or Passenger Airbag ON Indicator Does Not Illuminate with Passenger Present After SDM Reprogramming

Models: 2012 Chevrolet Camaro
2013 Chevrolet Malibu

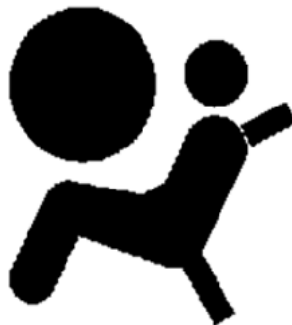
Passenger Airbag Indicator (Malibu)

Some customers may comment that driver airbag light is flashing in the cluster and/or the passenger airbag ON indicator does not illuminate when a passenger is present.

This condition occurs when the SDM (Inflatable Restraint Sensing and Diagnostic Module) setup has not been completed after reprogramming. If the Setup is not completed, the airbag indicator located in the cluster will flash continuously and the "Passenger Airbag ON" indicator will not transition to ON when a person is in the passenger seat.

During the SDM re-programming process there are two steps required to be performed using the SPS (Service Programming System). The two steps on the supported controller screen are:

- SDM Inflatable Restraint Sensing and Diagnostic Module – Programming
- SDM Inflatable Restraint Sensing and Diagnostic Module – Setup

Using the SPS tool, select "SDM Inflatable Restraint Sensing and Diagnostic Module – Setup" on the Supported Controllers screen.
