| | GROUP<br>Chassis | MODEL<br>Optima<br>(TF/QF/HEV)<br>2011/13MY |
| | NUMBER<br>039 | DATE<br>September 2012 |
| <b>TECHNICAL SERVICE BULLETIN</b> | | |
| SUBJECT: CAUTION DURING REAR UPPER ARM SERVICE | | |

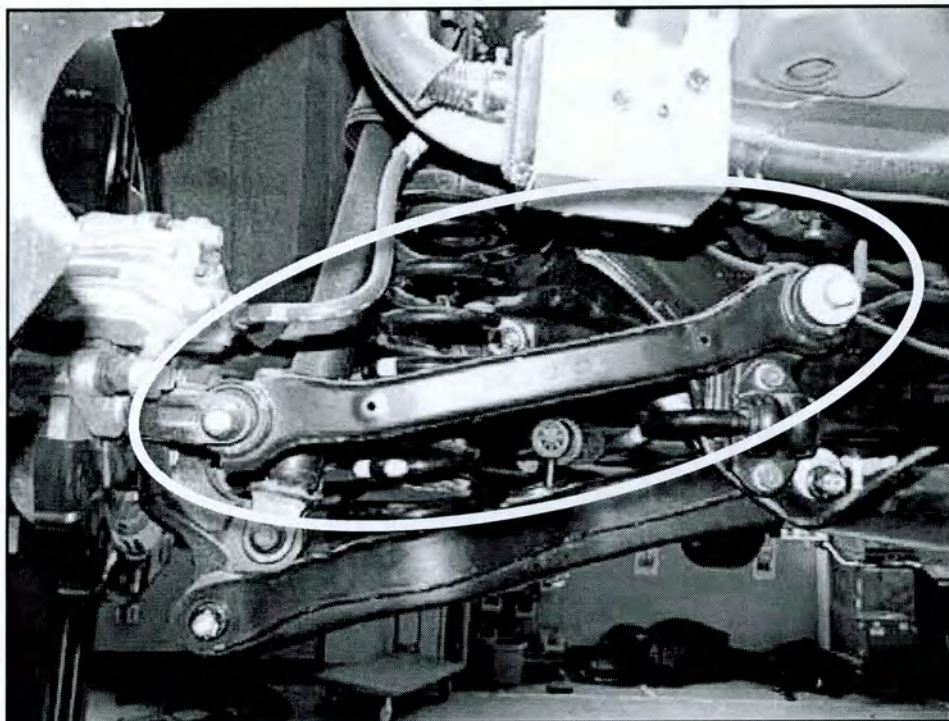
This bulletin provides cautionary information relating to the Optima when installing the rear upper arm to the subframe to prevent potential quality concerns regarding rear upper arm bolt. Without properly aligning the bolt holes of rear upper arm and subframe (horizontally), the bolt securing the rear upper arm to the subframe may become loose, and as a result, rust and noise concerns may occur later on.
