**SUBARU**

SERVICE BULLETIN

NUMBER: 11-124-12R

SUBJECT: Difficulty Starting, Rough Idle, Cam Position or Misfire DTCs P0301, P0302, P0303 or P0304 DTCs P0340, P0341, P0345 or P0346

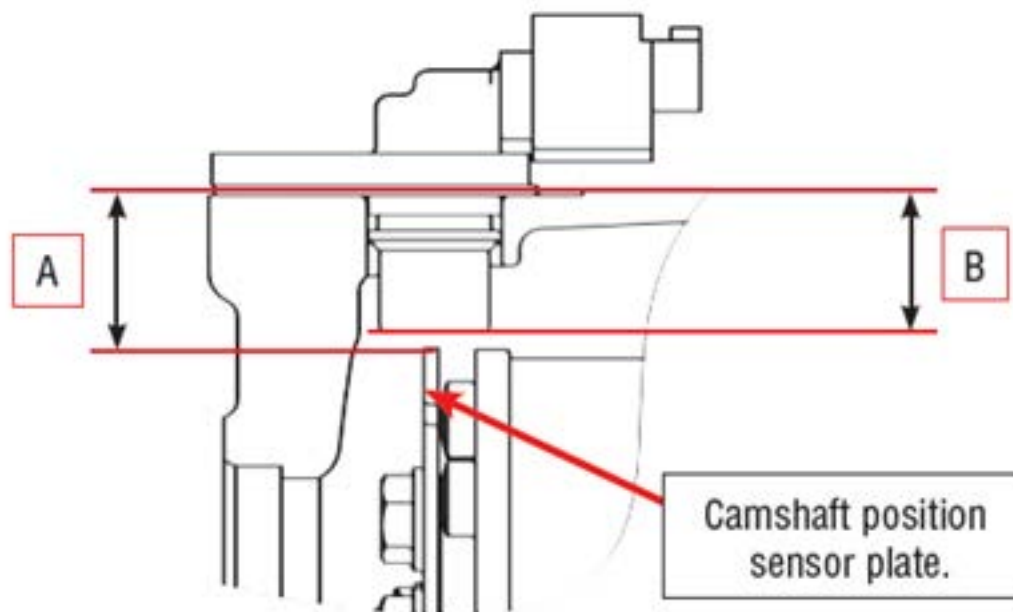
MEASUREMENTS:

A= Top surface of the timing chain cover to camshaft sensor plate

B= Camshaft Position Sensor mating surface to the bottom of the sensor

NOTE: When measuring “A”, make sure you are measuring to the outside diameter or “top” of the sensor plate and not to the bottom of a notch as shown below. Be sure to record all measurements.

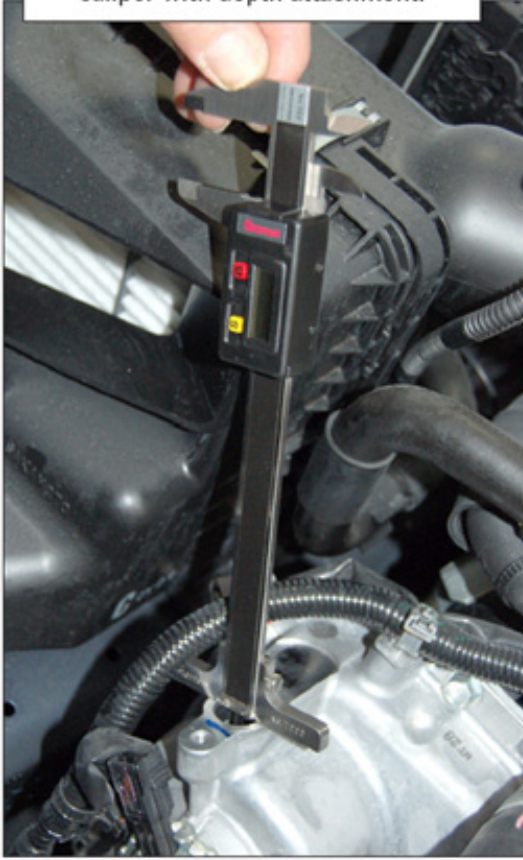
Measurement taken using digital caliper with depth attachment.

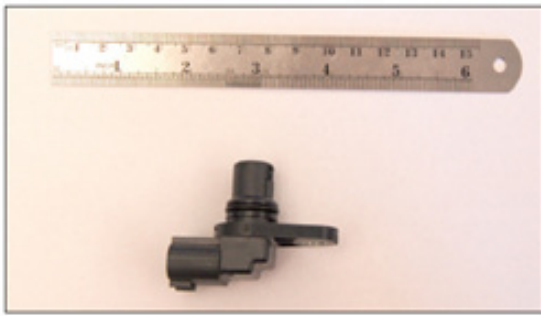
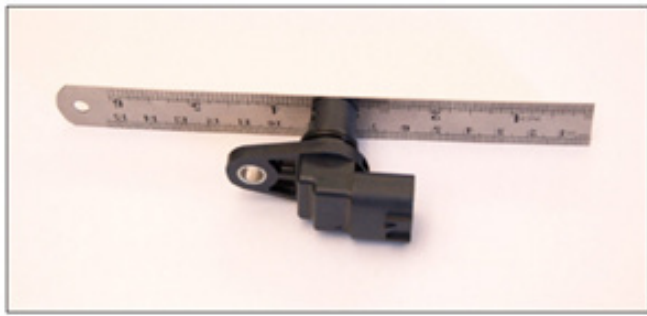
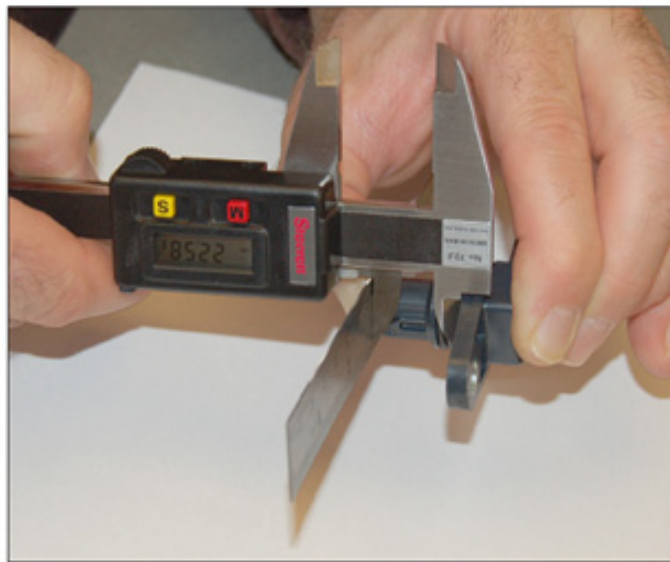
When taking measurement “B”, use a flat steel ruler or equivalent.

Measure the camshaft position sensor mating surface (the area that sits flush on the timing chain cover) to the bottom of the sensor and record measurement.

IMPORTANT: Be sure to account for the thickness of the flat washer when performing your calculations to determine the required shim thickness.
