Technical Service Bulletin

94 Headlight Warning On in Cluster (Xenon Plus With or Without Adaptive Light)

94 12 99 2029194/2 November 30, 2012. Supersedes Technical Service Bulletin Group 94 number 12-74 dated April 23, 2012 for reasons listed below.

Model(s)	Year	VIN Range	Vehicle-Specific Equipment
Q7	2010-2014	All	Premium Plus and Prestige

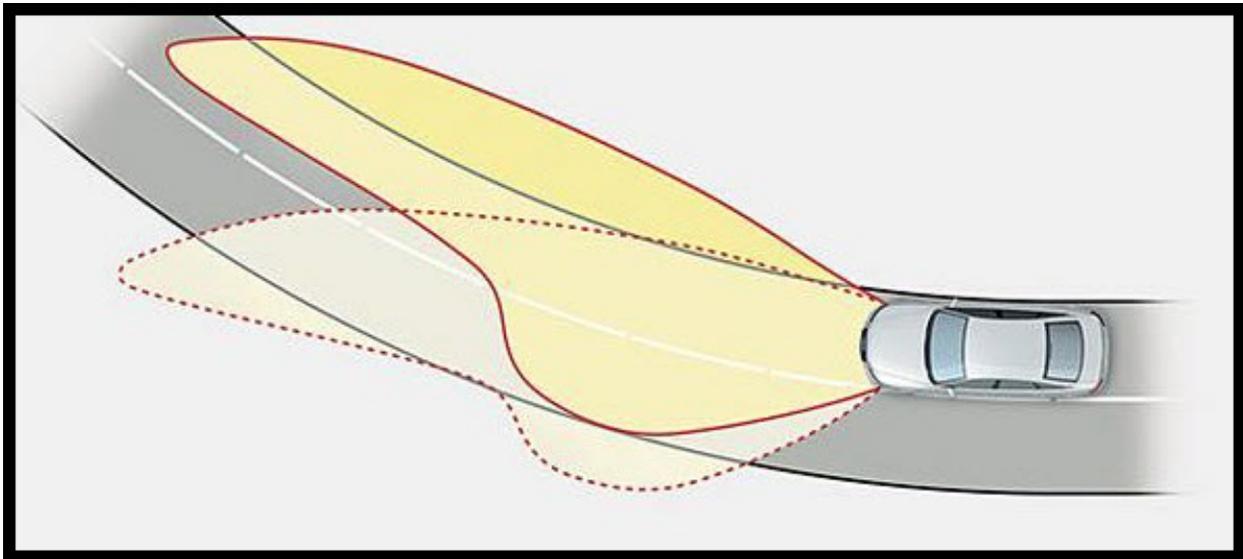
Figure 5. Audi Adaptive Lighting illustration showing the maximum 15° curve of the light beam at speeds greater than 6mph.

5. If no loose connector is found and the issue still persists then the issue, is outside the scope of this TSB and the remaining steps can be skipped. A swap of headlamp components between left and right is the next logical step to narrow down the failed part of the headlamp.
6. Reassemble the headlamp and install it back in to the vehicle.
7. Clear the DTC(s) and retest with low beams activated, high beams activated, and all turn signals activated.
8. If no DTC' s return, test the headlamp functionality in the garage or parking lot but also perform a short road test and repeat the actuation of all headlamps functions while at a speed. To test the adaptive light function (if equipped) the vehicle will need to be driven at speed around a corner at a speed greater than 6mph.
