**SERVICE BULLETIN**

**APPLICABILITY:** 2012 and 13MY Impreza and XV Crosstrek™ **NUMBER:** 11-125-12  
 Models Equipped With FB Engine **DATE:** 12/03/12

**SUBJECT:** DTCs P0365, P0366, P0390 and P0391  
 Misfire DTCs P0301, P0302, P0303 and P0304

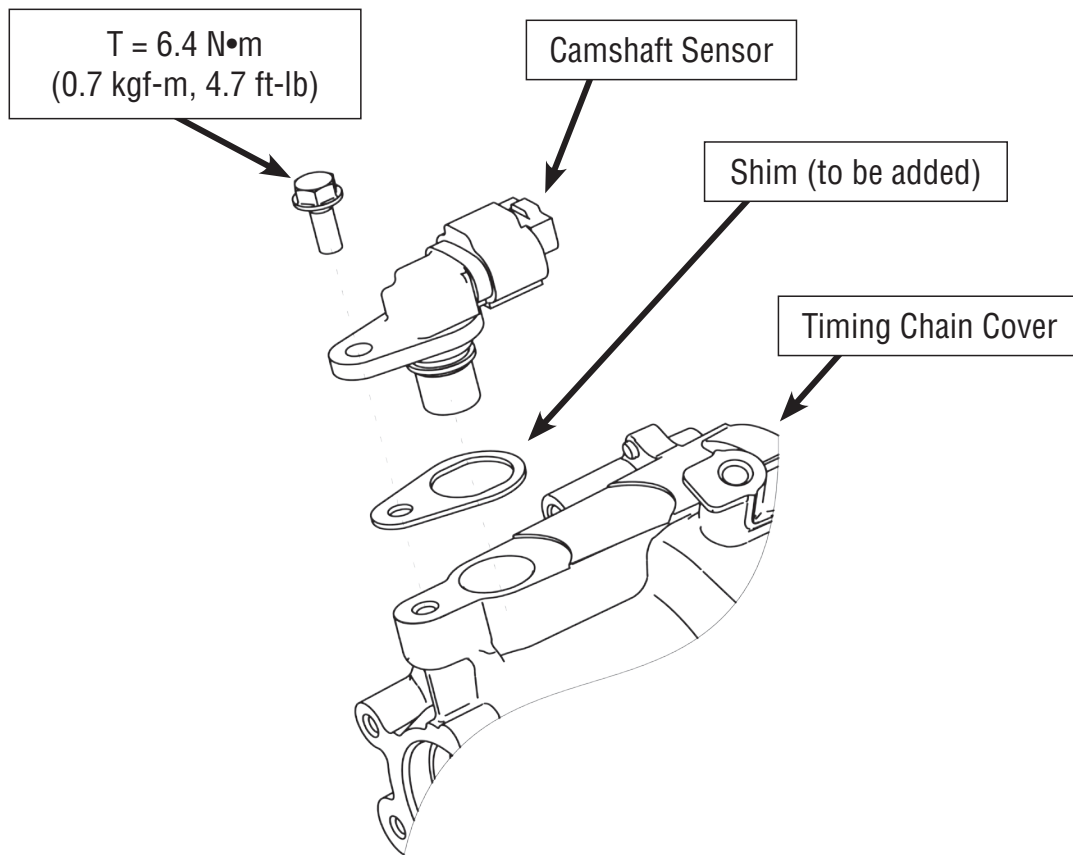
**The specified clearance is 1.3 +/- .05mm (1.25 to 1.35mm or .049" to .053").**

- Record radio station presets (and navigation system favorites if applicable).
- Disconnect the negative battery cable.
- Raise the vehicle on a lift and remove the engine under-guard.
- Remove the exhaust camshaft position sensor from the timing chain cover using the procedure in the applicable Service Manual.
