**PREVOST**ENREGISTRÉ - REGISTERED  
**ISO 9001 & ISO 14001****MAINTENANCE  
INFORMATION**

MI12-40

| DATE : | OCTOBER 2012 | SECTION : | 06 - Electrical |
| SUBJECT : | LOAD DUMP PROTECTION 50DN ALTERNATOR | | |

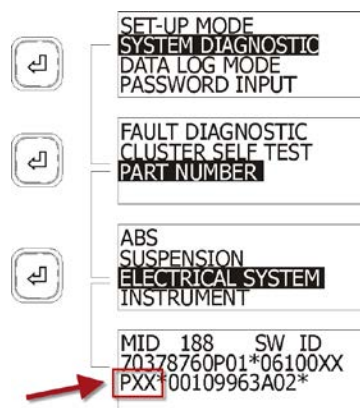
*After the modification, you will hear the master relay clicking OFF 3 sec after key is turned OFF*

11. Splice a new 85J red 18ga wire on SP17 using #562228 butt splice and heat shrink tube #562499.
12. Connect other end of 85J to JA14 on A36 module. Crimp terminal #562771 with crimper #683765.
13. In the Message Center Display (MCD), verify multiplex software version. (Version should be P17 and later)
14. Follow this menu sequence to verify the software version of the multiplex system.
15. If version is P16 or earlier, reprogram the multiplex to the latest version.
