The Professional Publication for Kia Dealership Technicians & Service Staff

Forte Lock Confirmation Inoperative on Remote Start Equipped Vehicles

10 • TECH TIMES - Volume 15, Issue 5 - 2012

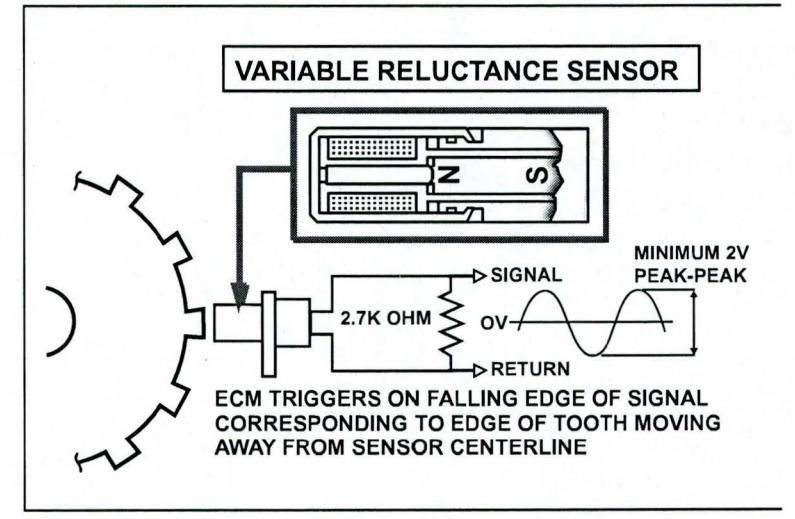
The sensor can be measured with an oscilloscope. Simply disconnect the sensor and place the oscilloscope across the sensor terminals. Crank the engine for the CKP, or rotate the wheel for a WSS.

These values vary by year and model.
