SERVICE BULLETIN

APPLICABILITY: 2011-2012MY Forester Models with FB Engine **NUMBER:** 02-131-12R
SUBJECT: Oil Seepage Diagnosis and Repair Procedures **DATE:** 07/18/12
REVISED: 10/02/12

INTRODUCTION

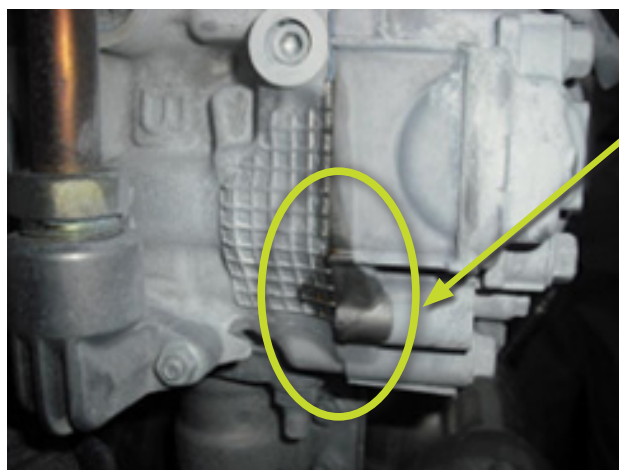
Cam carrier seepage seen from top left and lower right side of engine

If oil seepage is verified coming from between the cam carrier and the cylinder head as shown in the photos below, remove the cam carrier. Clean the machined sealing surfaces thoroughly and then re-seal using Liquid Gasket ThreeBond 1280B, (Part No. SOA5499100) or equivalent*. As shown in the photos below, the o-rings between the cam carrier and the cylinder head will need to be replaced as they are not re-usable. This would also be a good time to clean the Active Valve Control System (AVCS) filter screens which are contained in the cam carriers. **NOTE:** The filter screens are one-time use and must be replaced if they need to be removed. The replacement filter part# is 14451AA050.
