Technical Service Bulletin

91 MMI 3G+ Various Technical Issues (K0566 Update)

91 12 60 2030465/3 September 24, 2012. Supersedes Technical Service Bulletin Group 91 number 12 – 59 dated September 17, 2012 for reasons listed below.

Model(s)	Year	VIN Range	Vehicle-Specific Equipment
A6	2012	All	MMI 3G+
A7	2012		
A8	2011 – 2012		
Audi Q7	2012

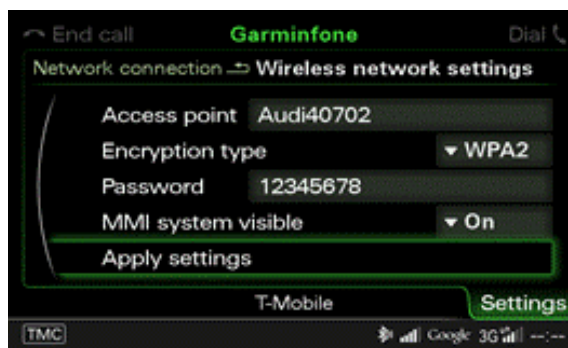
Figure 1. Wireless network settings.

1. As part of the update, wireless settings and paired devices will be deleted. All devices will need to be re-paired after the update, and all wireless settings restored to the customer's settings. To access the Wireless network settings on the MMI (Figure 1), press *TEL >> Settings >> Wireless network connection >> Wireless network settings*. Record all settings so they can be re-entered at the end of the update.
