Service Bulletin

**SUBJECT: Service Update for Inventory Vehicles Only
Steering Wheel Doesn't Heat, Horn Continuous, Battery Drain
Expires December 31, 2013**

MODELS: 2013 Cadillac XTS

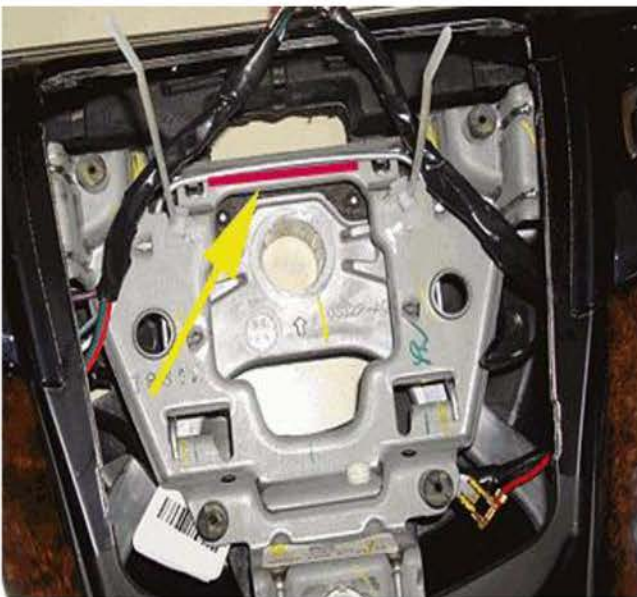
2. Inspect the steering wheel metal base plate.
 - If you see a RED or BLACK line under the airbag retention spring between the left and right branches of the main wire harness, the steering wheel has already been reworked. No further rework is required. Inspect the wiring and ensure there is no damage to wires and reposition the heated steering wheel wire harness as shown in UVD step #5. Reinstall the airbag module into the steering wheel.
 - If no black or red indicator is found, proceed to step 3.
