Service Bulletin

PRELIMINARY INFORMATION

Subject: Retrofit Procedure for New Corded Folding Top Cover Installation to Original Design Frame

Models: 2011-2012 Chevrolet Camaro Convertible

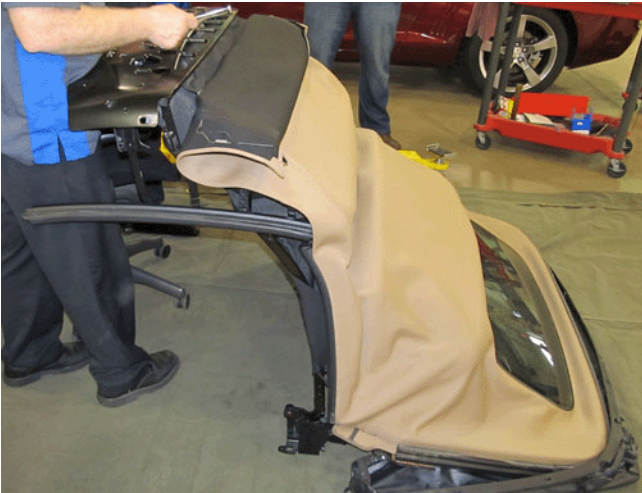
Note: The fore/aft control cords were removed on the new top cover design. During reassembly, attachment to the 1 bow does not occur as in the previous design.

6. Start removing the top cover from the #1 bow exposing the entire top side of the #1 bow casting. Remove the large header garnish molding by accessing the fasteners from the top side of the #1 bow. Disassemble the headliner from the #1 bow and disconnect the top cover fore/aft control cords from the #1 bow. Drill out the top cover side strap rivets attached to the rear #1 bow link and control links. Refer to Folding Top Cover Replacement in SI.

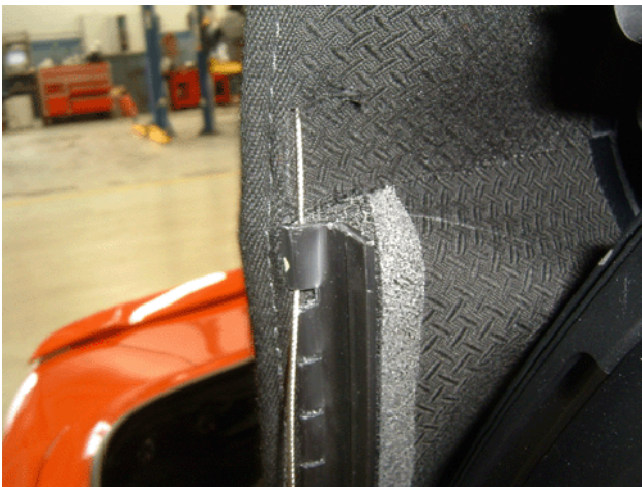
Instead of a slit in the plastic, the retainer now has a large square hole at the very end, which is large enough to allow the cable anchor to pass through it. The retainer and square hole can be seen in the graphic below.

- 26.1. Starting on the left side, route the side tension cable through the backside of top cover edge plastic retainer as shown above.

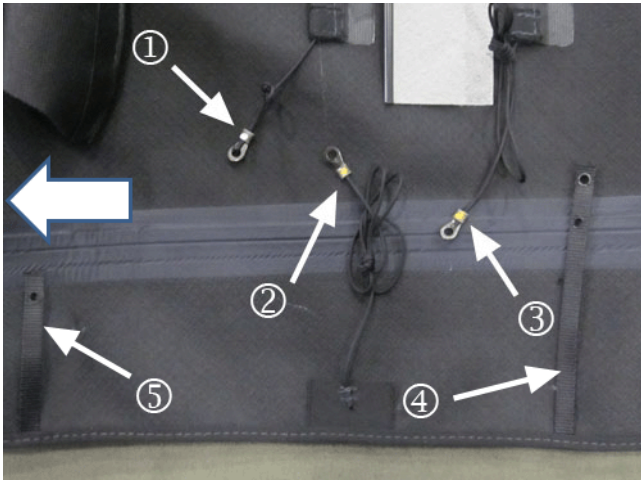
Note: The three cords added to each side of the top cover are color-keyed with paint dots on the cord eyelets. The orientation of the three colors white (1), yellow (2) and orange (3), along with the rear (4) and front (5) control straps, are shown above. The following steps will reference them as the white, yellow or orange control cords.
