SERVICE BULLETIN

APPLICABILITY: 2013MY BRZ

NUMBER: 02-137-12

SUBJECT: DTCs P0017 and P0019

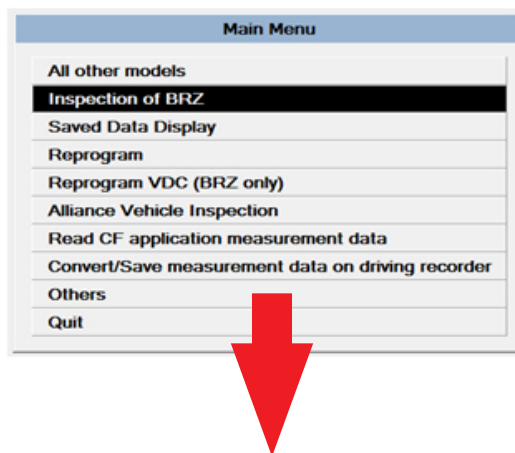
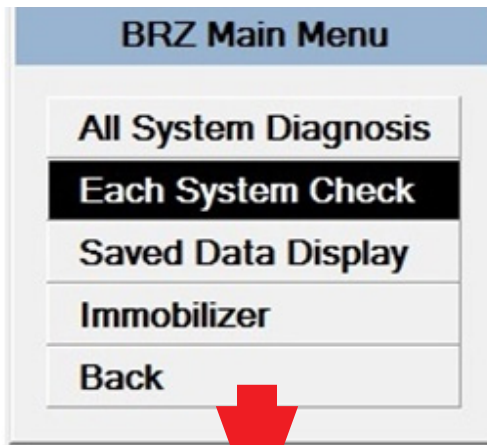
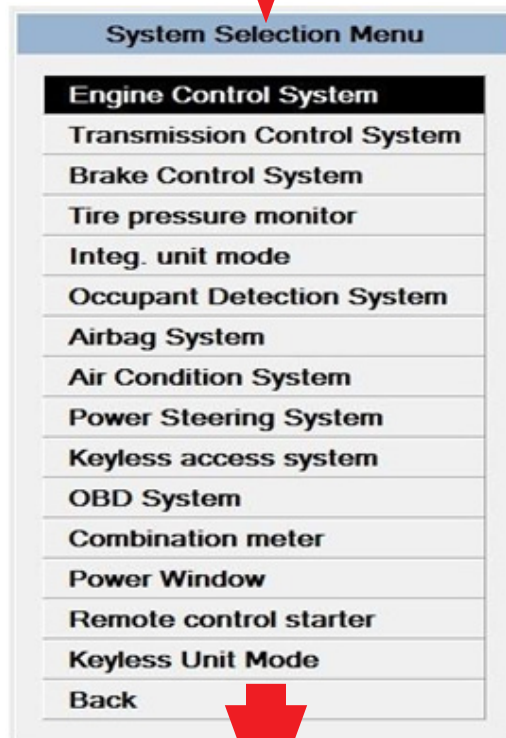
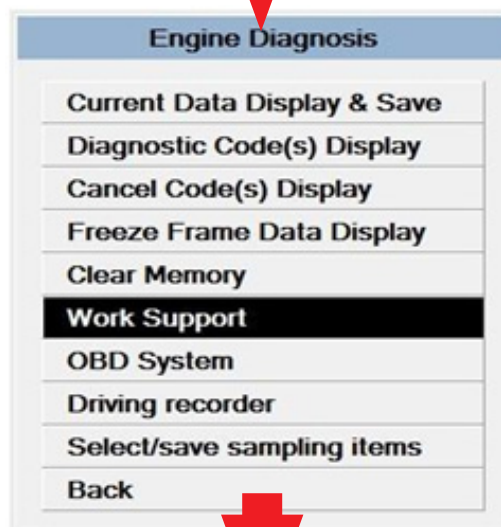
- Connect the SSMIII to the vehicle.
- From the Main Menu, follow the selection steps shown in the following screen shots.

NOTE:
The DTCs in this bulletin are only applicable to the EXHAUST (Ex) values #1 and #2

- After reviewing the data, if the values are within the specified limits, **REPROGRAM** the ECM.
- After reviewing the data, if the values are outside the specified limits, **REPLACE** the ECM.
- **IMPORTANT:** After ECM replacement, the Calibration Identification (CID) number of the ECM must be verified to be the latest version available.
- After reprogramming or replacement of the ECM is completed, road test the vehicle to confirm no DTCs reset before returning the vehicle to the customer.
