# PREVOST

## WARRANTY BULLETIN

### WB13-55A

| SUBJECT : | WELD INSPECTION ON TRIPOD FAN SUPPORT | | |

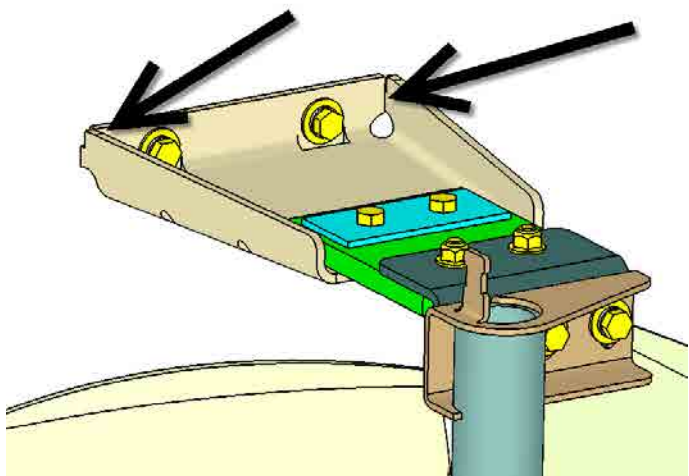
4. Use a telescopic mirror to inspect the support.
5. If there is no weld at the indicated locations, replace 053024.

**Prior to removal, perform step below**
