Service Bulletin

PRELIMINARY INFORMATION

Subject: SES Light, Engine Misfire, and/or Shudder - Inspect Ignition Coils

Models: 2009 Buick Enclave
2008-2009 Cadillac CTS, STS
2009 Chevrolet Traverse
2009 GMC Acadia
2009 Saturn Outlook
With Direct Injected 3.6L V6 Engine (RPO LLT)

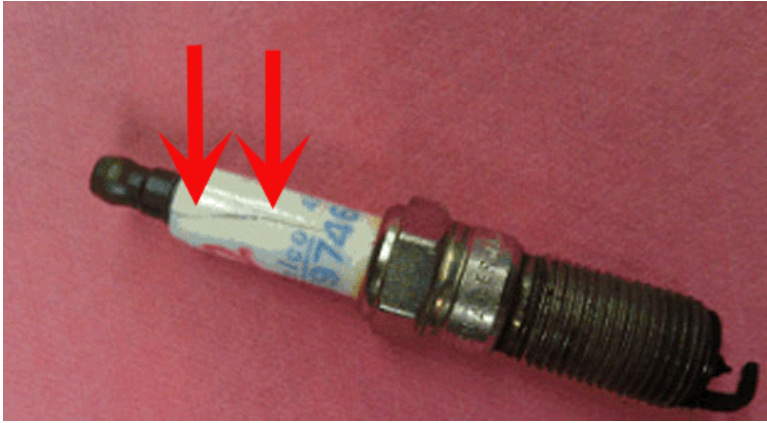
Events/conditions that can produce EMI transient include:

Spark plugs that are cracked, wrong plug gap, worn plugs, carbon fouling, and top post contact issues.

Corrosion - all prevents the coil charge to produce a healthy spark, which could reflect EMI transient back to the ECM.
