Program Bulletin

CUSTOMER SATISFACTION PROGRAM

SUBJECT: Power Steering Hose Leak

MODELS: 2006 Chevrolet Impala, Monte Carlo (V6 & V8 Engine)
2005-2006 Pontiac Grand Prix (V8 Engine)

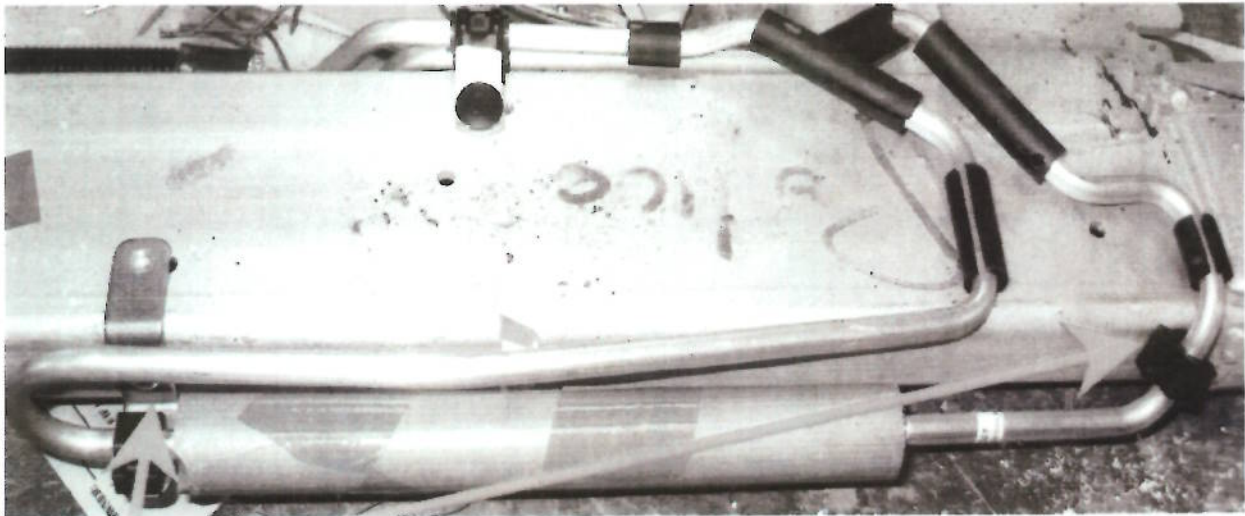
1854947

Note: The location of the leak (1) is shown above. Fittings on the hose are crimped socket and are not likely to leak.

- Two holes will be drilled for retro-fitting 2006 cradles with 2007 cooler pipe.
 - Technician will need to remove one clip from cooler pipe on top and replace with isolator, and move the other to the front face of the cradle (and replace with isolator).
 - Technician will need to glue down the two isolators with Instant Adhesive-Gel, P/N 12345632 (US), 10953475 (CN), or equivalent, such as SAF-T-LOK IB-45 (ETHILCIANOCRILATO).
1. Raise and support the vehicle. Refer to the *Lifting and Jacking the Vehicle* procedure in SI.
 2. Place a drain pan under the vehicle to capture the power steering fluid when disconnecting the power steering return line.
 3. Remove the air deflector.
 4. Remove the power steering cooler pipe/hose from the retaining clips on the frame.
