SUBJECT: Service Update for Inventory and Customer Vehicles
Turbo Vacuum Hose Routing - Inspect
Expires with Base Warranty

MODELS: 2014 Cadillac XTS
Equipped with 3.6L V6 Engine (LF3)

Subject: 13275 – Service Update Bulletin
Turbo Vacuum Hose Routing – Inspect

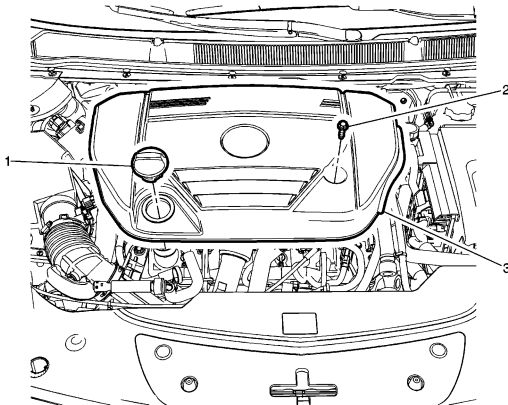
3330809

Note: Inspect the turbo charger wastegate actuator vacuum boost tube bundle for proper routing. In addition, inspect the condition of the tubing and clip attachments. Ensure tubing does NOT have any kinks or cuts. Replace damaged tubing or clip attachments.

- If the turbo charger wastegate actuator vacuum boost tube bundle (1) is routed correctly, no further action is required. Install the intake manifold cover and front compartment front sight shield. Refer to *Intake Manifold Cover Replacement* and *Front Compartment Front Sight Shield Replacement* in SI.

- If the turbo charger wastegate actuator vacuum boost tube bundle (1) is NOT routed correctly, disconnect the tube bundle from the attachment points and re-route the tube bundle. Install the intake manifold cover and front compartment front sight shield AFTER completing the repair. Refer to *Intake Manifold Cover Replacement* and *Front Compartment Front Sight Shield Replacement* in SI. Refer to the following sections in this bulletin for information about how to correctly route the turbo charger wastegate actuator vacuum boost tube bundle:
 - Charge Air Bypass Valve Vacuum Tank Tube Routing and Connection Aids on Engine
 - Charge Air Bypass Valve Vacuum Tank Tube Routing and Connection Aids At Turbo Wastegate Regulator Solenoid
