VOLUNTARY CAMPAIGN BULLETIN

SUBJECT:	Diesel Particulate Regeneration (DPR) Igniter Plugs
DATE:	03/01/2013
BULLETIN NO:	RCB-001-13
CAMPAIGN NO:	A8560
AFFECTED MODELS:	Certain 2011 through 2013 model year NE8J, NJ8J, NV8J models equipped with a J08 engine.

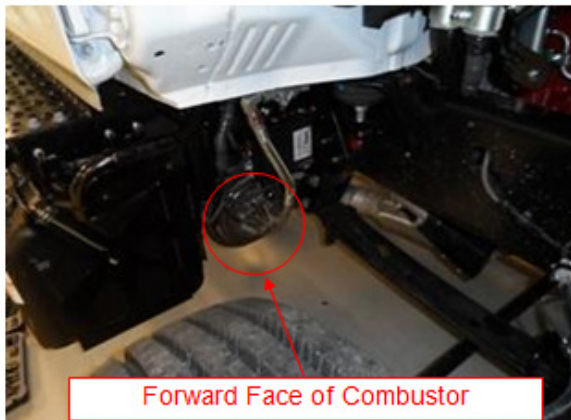
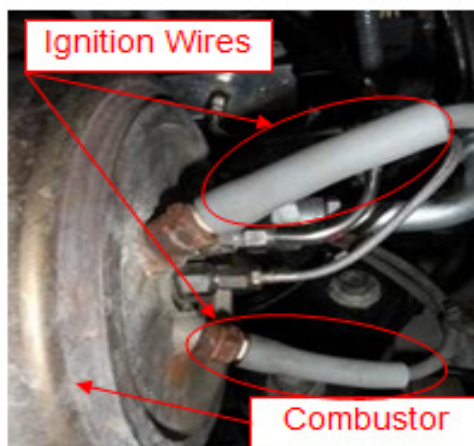
3. Locate the forward face of the combustor and disconnect the ignition wires from both ceramic igniter plugs.

When disconnecting the ignition wires, securely grasp the center of the ignition wire boot to prevent shifting of the electrical terminal and wire position within the boot.

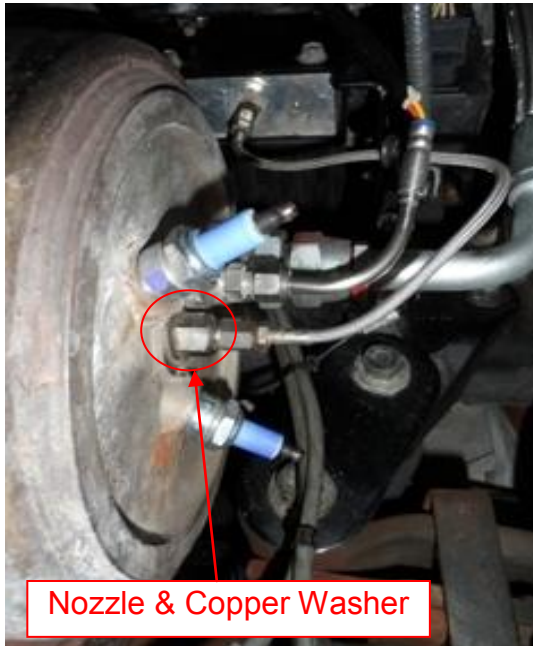
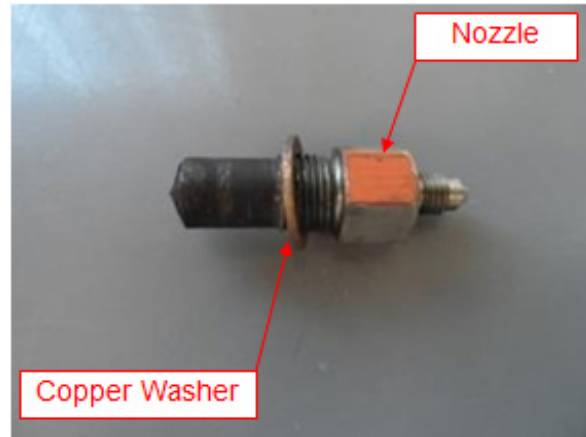
6. Remove the steel braided fuel/air supply line, nozzle and copper washer. Discard the copper washer.

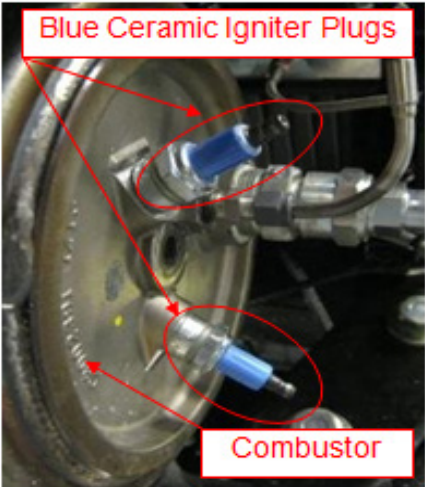
8. Remove both blue ceramic igniter plugs from the combustor.

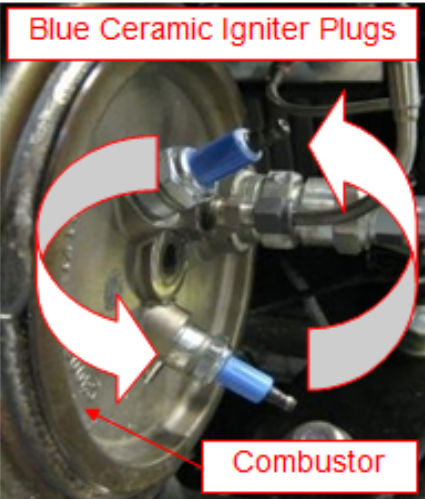
9. Switch igniter positions side to side. Reinstall both igniter plugs and torque to the specified torque.

Specified Torque: 22.0 lb-ft (29.8 Nm)

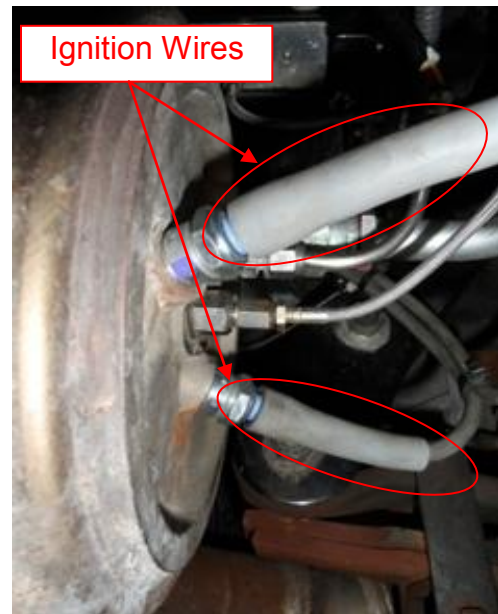
13. Install and electrically connect each ignition wire onto the corresponding blue ceramic igniter plug.

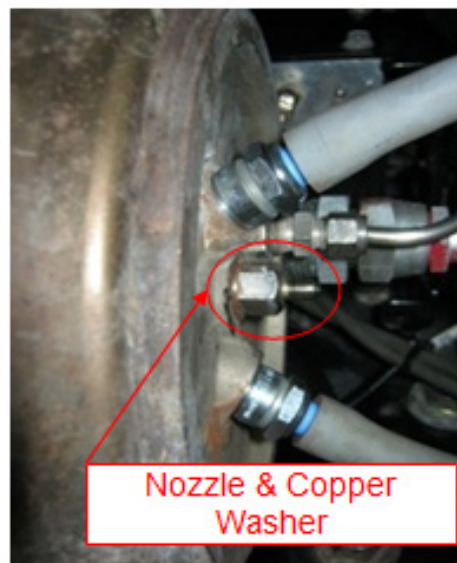
15. Using a new copper washer, install the nozzle and tighten to the specified torque.

Specified Torque: 19.9 lb-ft (27.1 Nm)

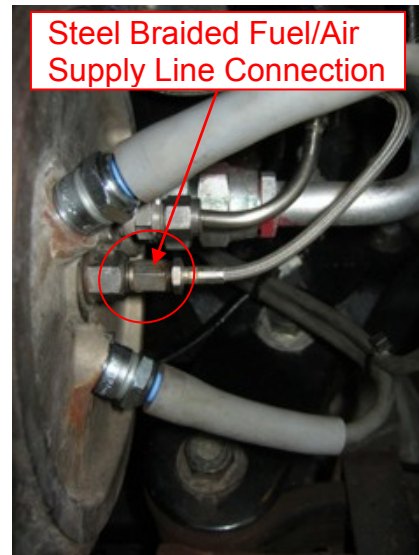
16. Connect the steel braided fuel/air supply line fitting at the nozzle and tighten to the specified torque.

Specified Torque: 8.3 lb-ft (11.3 Nm)

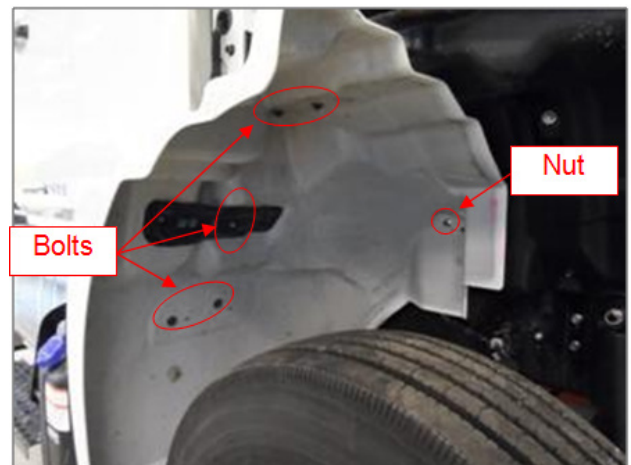
17. Install the right front fender and secure using one (1) nut and six (6) bolts (shown in the illustration to the right). Tighten each fastener to the specified torque value.

Nut: 9.6 lb-ft (13.0 Nm)

Bolt: 10.4 lb-ft (14.0 Nm)
