Technical Service Bulletin

96 False warning by lane change assistant (Audi Side Assist)

96 13 75 2033782/2 September 23, 2013. Supersedes Technical Service Bulletin Group 96 number 13-62 dated May 28, 2013 for reasons listed below.

Model(s)	Year	VIN Range	Vehicle-Specific Equipment
allroad	2013	All	Not Applicable

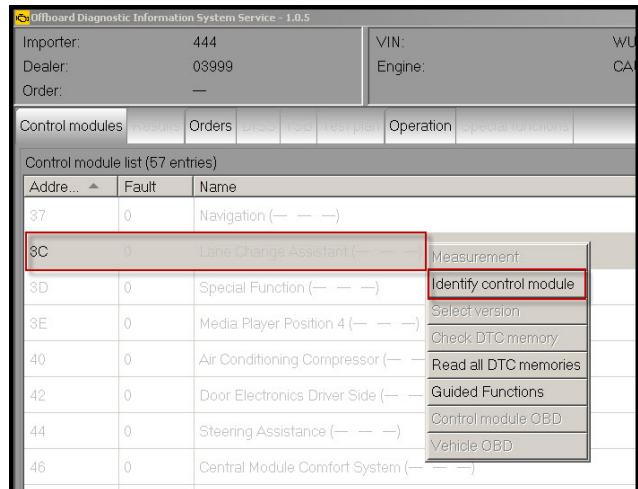
Figure 1. 3C Lane Change Assistant is greyed out until "Identify control module" is selected.

- Start *Diagnosis* -> *Fill out Engine Information from drop down menu* -> *Uncheck option for "Guided Fault Finding"* --> *Select Tab "Control module list"* --> *Scroll down list to "3C Lane Change Assistant" (ECU option will be greyed out)* -> *Right click on "3C Lane Change Assistant" and select "Identify control module"* (Figure 1).

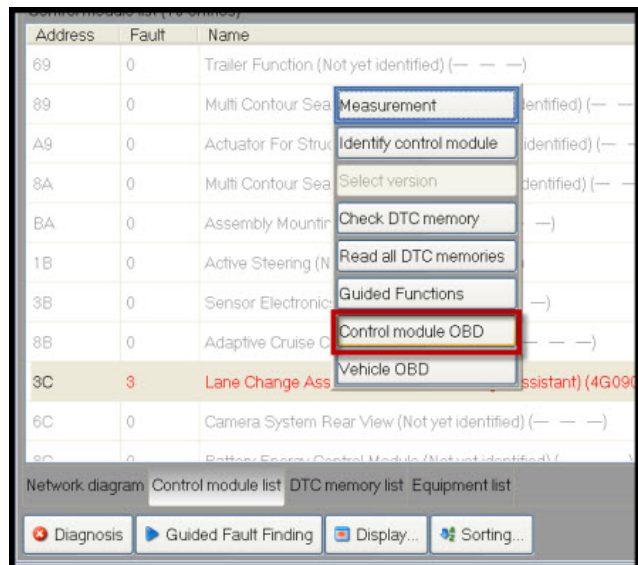
Figure 2. Control module ODB option is available after "Identify control module" completes.

- Once the information has populated, right-click on "3C Lane Change Assistant" and select "Control Module ODB" (Figure 2).

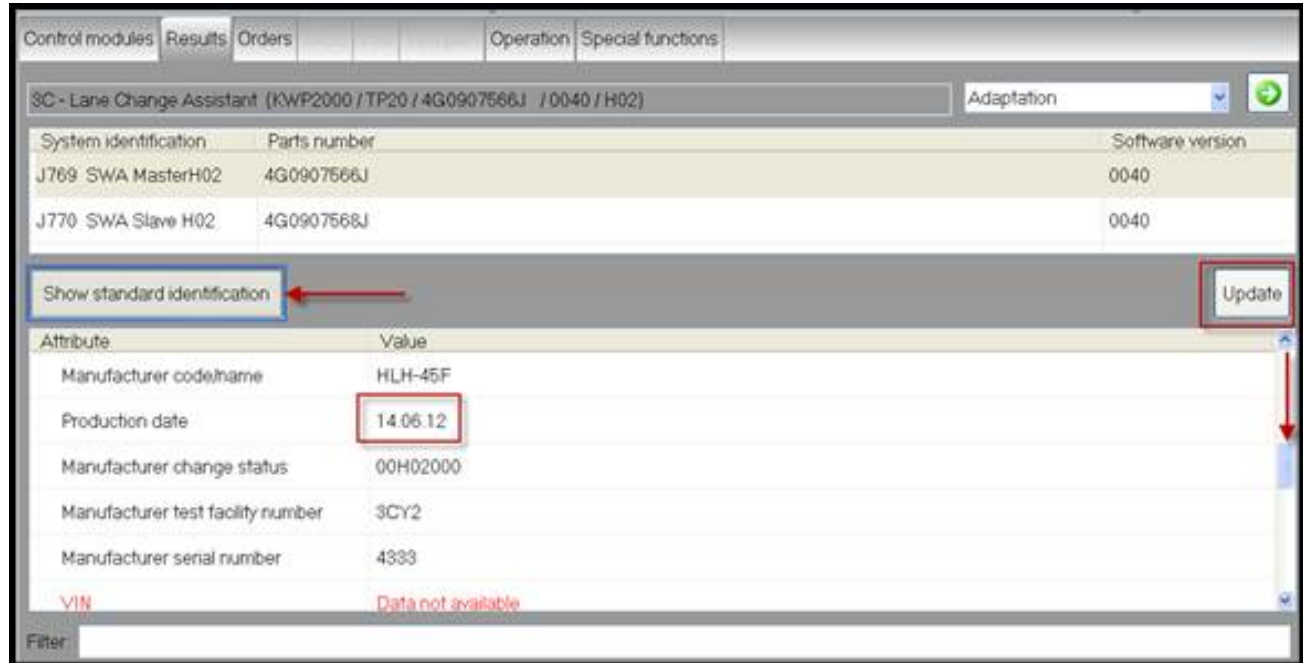
Figure 3. Control Module OBD screen showing part information and production date.

- Under the Results tab, click on the button “Show Advanced Identification” (Figure 3), and then select the “Update” button on the right.

The part number, hardware version, and software version information will automatically populate at the top of the screen
