Technical Service Bulletin

96 False warning by lane change assistant (Audi Side Assist)

96 13 81 2033782/3 December 6, 2013. Supersedes Technical Service Bulletin Group 96 number 13-75 dated September 23, 2013 for reasons listed below.

Model(s)	Year	VIN Range	Vehicle-Specific Equipment
A4 allroad	2013	000001-999999	Audi Side Assist (PR Code 7Y1)
A4 allroad	2014	000001-057893	Audi Side Assist (PR Code 7Y1)

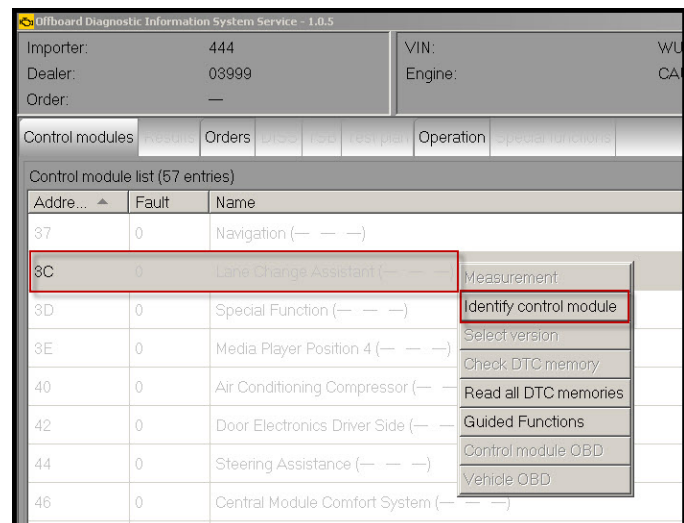
Figure 1. 3C Lane Change Assistant is greyed out until "Identify control module" is selected.

- Start *Diagnosis* -> *Fill out Engine Information* from drop down menu -> *Uncheck option for "Guided Fault Finding"* --> *Select Tab "Control module list"* --> *Scroll down list to "3C Lane Change Assistant"* (ECU option will be greyed out) -> *Right click on "3C Lane Change Assistant"* and select *"Identify control module"* (Figure 1).
- Wait for the information to populate. This usually takes 5-10 seconds.

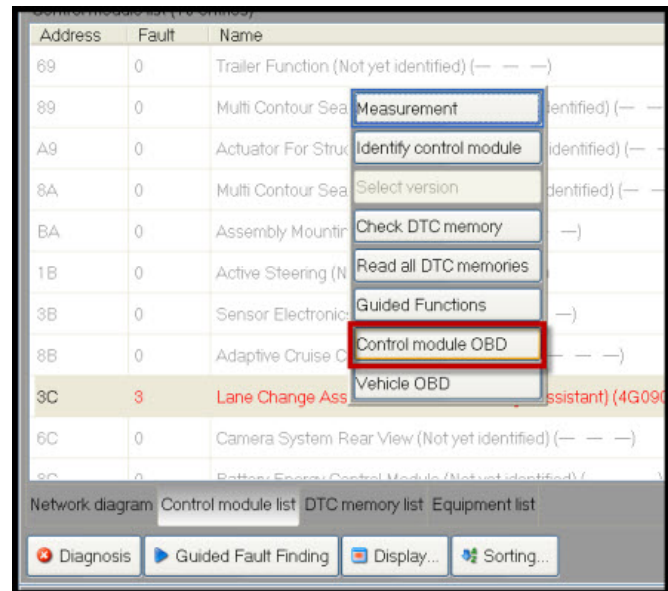
Figure 2. Control module ODB option is available after “Identify control module” completes.

- Once the information has populated, right-click on “3C Lane Change Assistant” and select “Control Module ODB” (Figure 2).
- Wait for the Control module ODB Results tab to populate the ECU information.

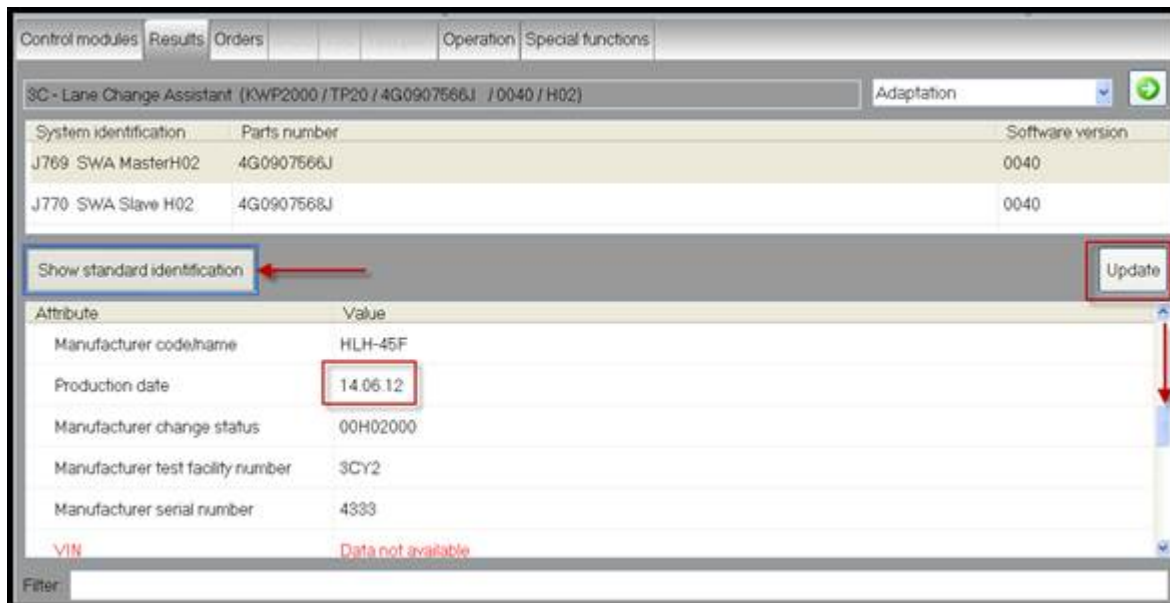
Figure 3. Control Module ODB screen showing part information and production date.

- Under the Results tab, click on the button “Show Advanced Identification” (Figure 3), and then select the “Update” button on the right.

The part number, hardware version, and software version information will automatically populate at the top of the screen
