# Technical Service Bulletin

## 91 Bluetooth call quality issues for caller on other end of call

91 13 11 2027718/5 October 31, 2013. Supersedes Technical Service Bulletin Group 91 number 13-86 dated June 11, 2013 for reasons listed below.

Model(s)	Year	VIN Range	Vehicle-Specific Equipment
TT, A5 Cab, A6, A7, A8	2011 - 2014	All	Bluetooth hands-free telephone system

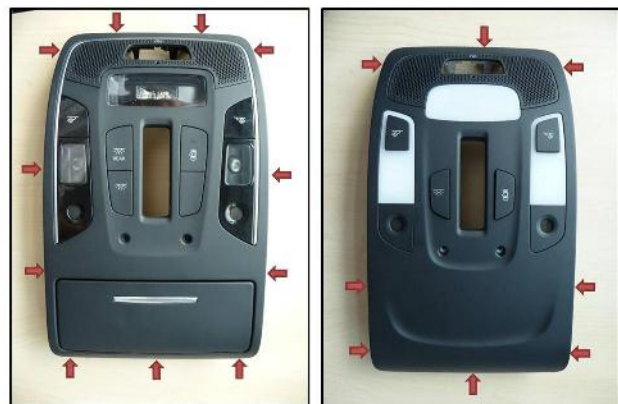
- Remove the decorative trim from the base plate with your fingers. If necessary, gently pry the trim with a trim stick or bone tool, then finish removing it with your fingers.
- There are a number of different clips holding the trim plate to the base plate depending on the trim level of the vehicle (Figure 1).

**Figure 1.** Clip location for A6/A7 high-line roof module (left) and for mid-line roof module (right)

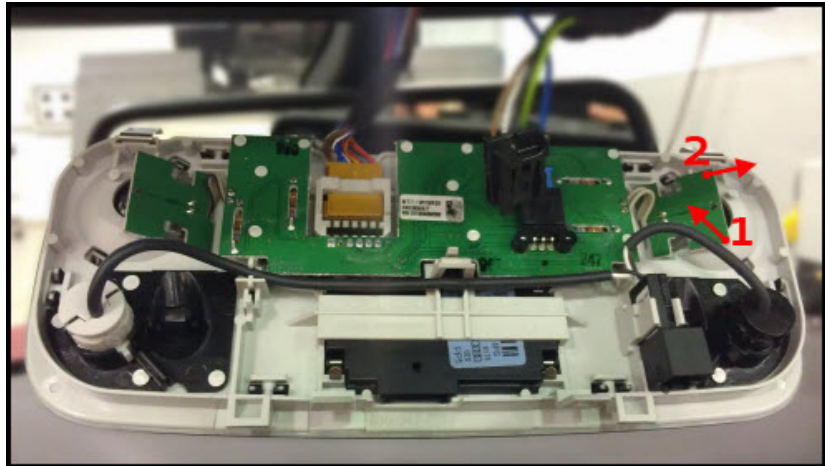
**Figure 2.** Prying the LED circuit-board of the jewel.

- To remove the LED circuit boards, first pry the top of the small circuit board away from the LED jewel, in the direction indicated by arrow 1 (Figure 2). It will only need to be lifted 1-2mm. Then, pull up on the circuit board in the direction indicated by arrow 2 (Figure 2) to release the circuit board from the LED jewel. There are three different attachment points of the LED circuit board and LED jewel (Figure 3).

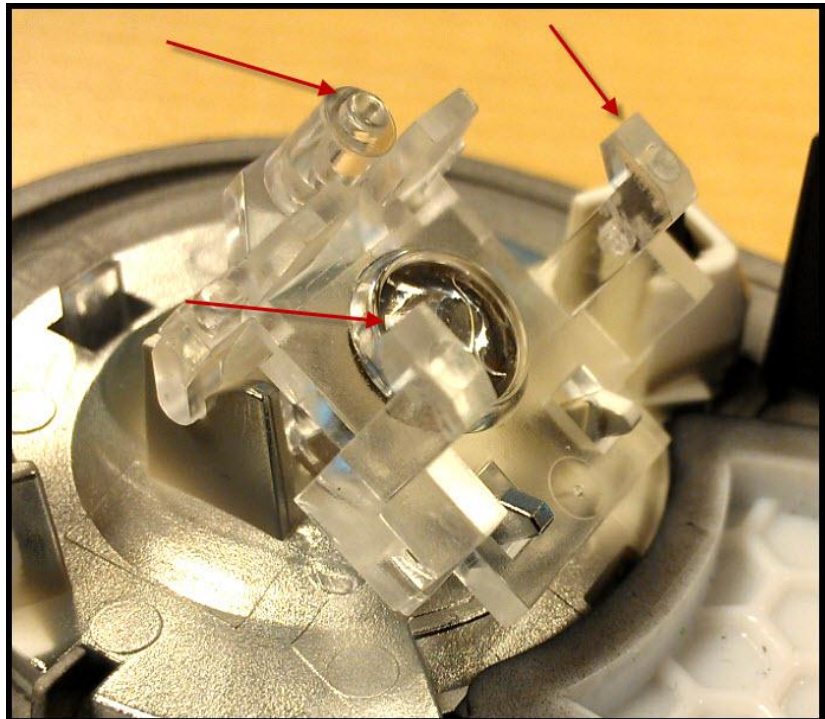
**Figure 3.** LED jewel attachment points.

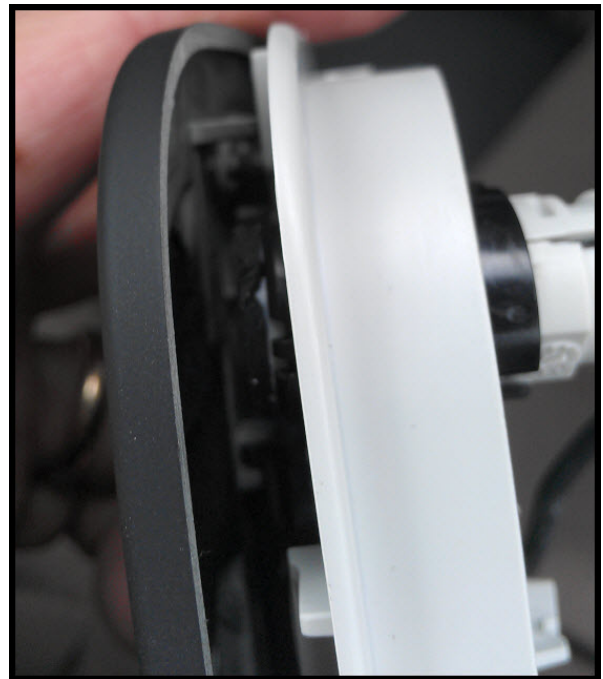
*Figure 4. Prying the trim plate from the base plate.*

- Repeat for the other side.
- Once the LED jewels are free from the circuit boards, the decorative trim plate can be detached from the base plate. Use your fingers to pry the two pieces apart. There are many clip points holding the two pieces together. Sliding your finger slowly around the perimeter is the most effective way to separate the two parts without damaging them (Figure 4).

The use of a bone tool or screw driver is not recommended for this roof module assembly because it can damage the soft touch paint on the edge of the trim, which can be visible once the part is reinstalled in the headliner.

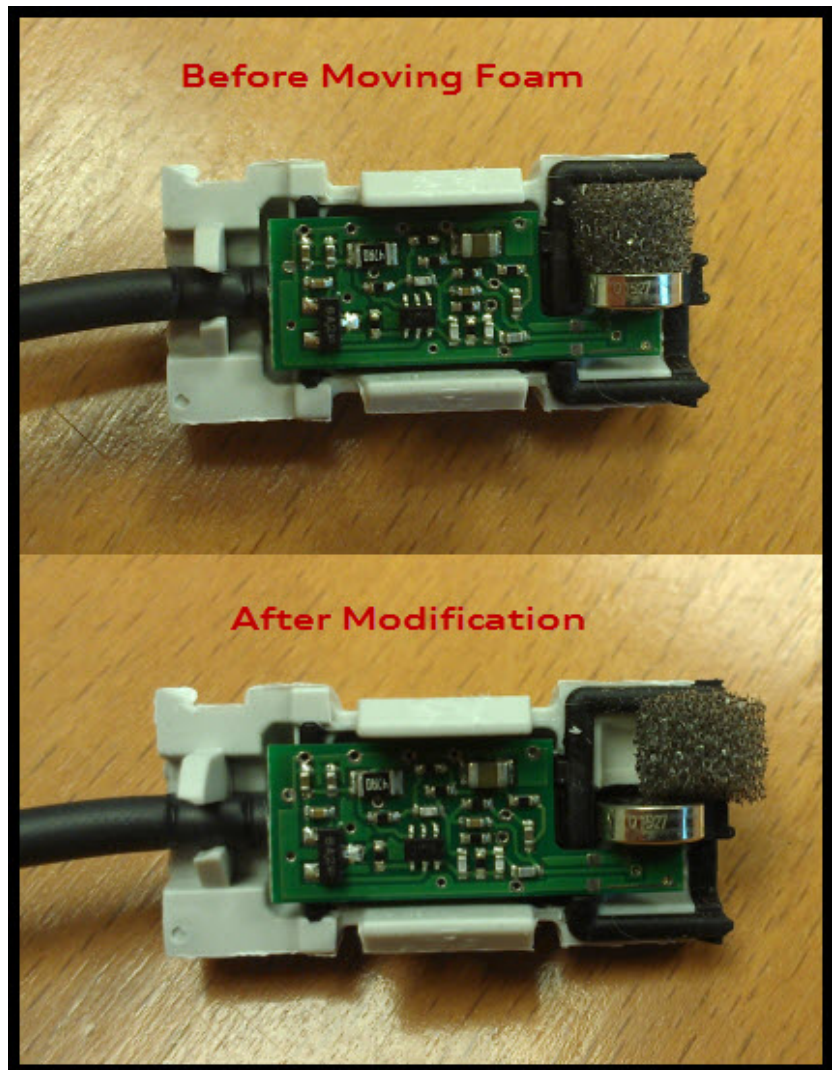
*Figure 11. Foam is partially pulled out of the microphone.*

- Before installing the new microphone, partially pull out the foam that is inserted in the microphone to allow for a better seal against the felt material (Figures 11 and 12).

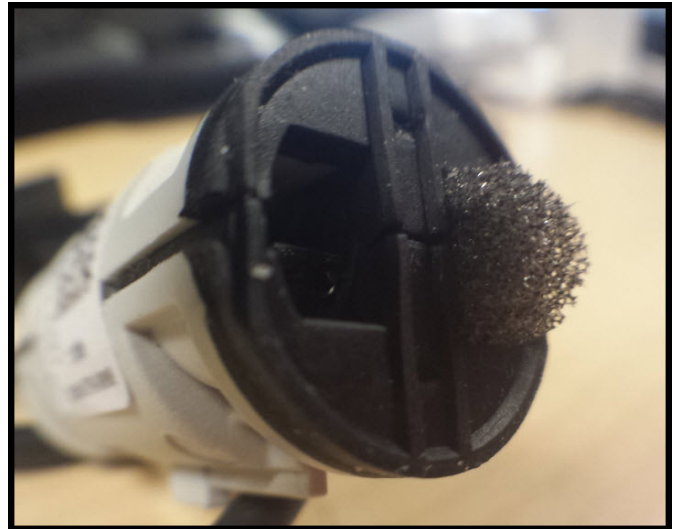
**Figure 12.** Foam is partially pulled out of the microphone.
