Technical Service Bulletin

94 Daytime Running Light (DRL) inoperative

94 13 21 2032184/2 July 9, 2013. Supersedes Technical Service Bulletin Group 94 number 13-05 dated February 8, 2013 for reasons listed below.

Model(s)	Year	VIN Range	Vehicle-Specific Equipment
Q5	2013 - 2014	All	Audi Xenon Plus with LED Daytime Running Lights

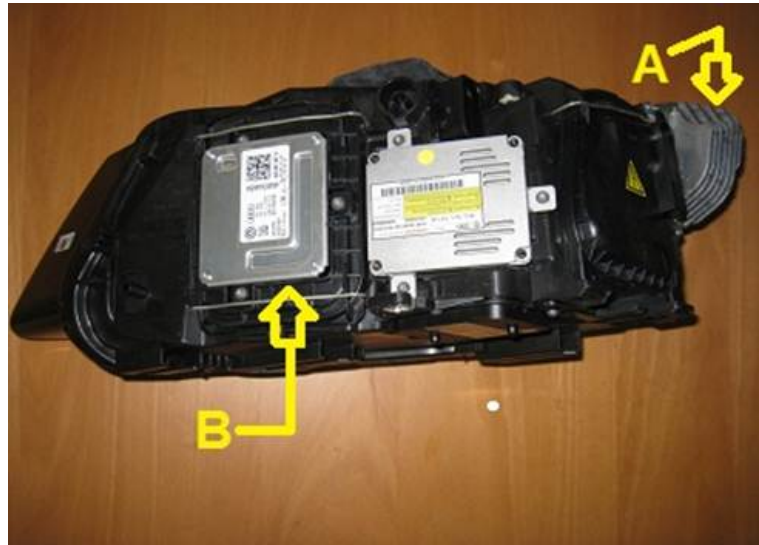
The LED unit with heat sink utilizes a gasket and is keyed into the headlight housing to maintain proper alignment of the LED to each light pipe. The LED units (L176 and L177, left and right, respectively) are controlled via a control module (J860 and J861, left and right, respectively) located separately on the backside of the headlight (Figure 2). These LED units and LED control modules are electrically interchangeable from side to side, but the LED units are mechanically specific to each headlight side.

Figure 2. Backside of headlight with LED heat sink (A) and LED control module (B).

1. With ignition off, remove DRL control module and check red connector at module. Secure it, if loose. If necessary, remove red connector and reinstall to be sure connector is engaged properly. The wire guide of the red terminal housing may impede connector engagement.
2. Turn ignition on to see if DRL is now operating to specifications. If it is not, proceed to step 3.
3. Remove headlight(s) according to the instructions in ElsaWeb. See *Repair Manual* >> *Electrical System* >> *Electrical Equipment* >> *94 Exterior Lights, Switches* >> *Removal and Installation*.
4. With ignition off, remove LED DRL unit with heat sink from headlight housing (Figure 6).

5. With ignition off, inspect and secure all electrical connectors, if loose. Remove and secure the white connectors, even if they do not appear to be loose.
