01 MIL on (DTC P2006(00) or P2007(00))

01 13 26 2033919/10 August 29, 2013. Supersedes Technical Service Bulletin Group 01 number 13-20 dated August 2, 2013 for reasons listed below.

Model(s)	Year	VIN Range	Vehicle-Specific Equipment
A6, A7, S4, S5, S5 Cab, Q7, Q5	2013	All	3.0 FSI Engine

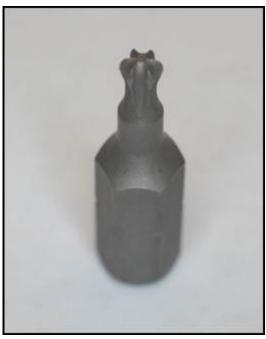
Figure 4. T10 ball head torx bit.

Tip: The T10 ball head torx bit is sourced locally (Figure 4). Examples include: Snap-on Tools SDM32KT or SDMBT10, or VIM Tools VIS108 or VIS112.

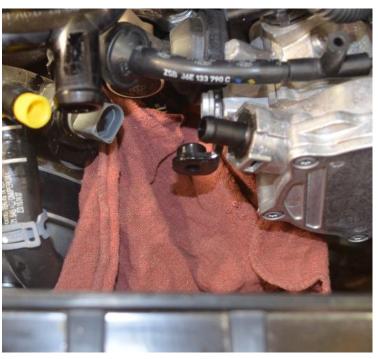
Figure 12. Place a shop rag under the screws.

Tip: Place a shop rag under the screws to catch any screws that drop (Figure 12).

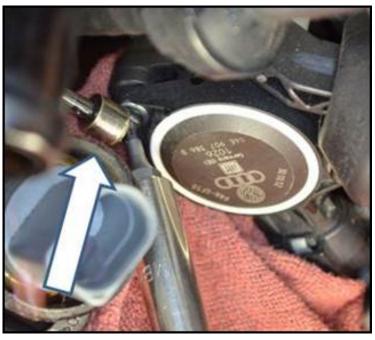
Figure 13. Use a magnet (arrow) to hold the screws during removal.

Tip: To prevent losing the screws, use a non-bonding adhesive on the tip of the ball torx bit and use a magnet to hold them during removal (Figure 13).
