# Service Action

Code: 64C9

Subject: 2012 – 2013 MY Volkswagen Beetle  
Front Window Motors

**REVISION**

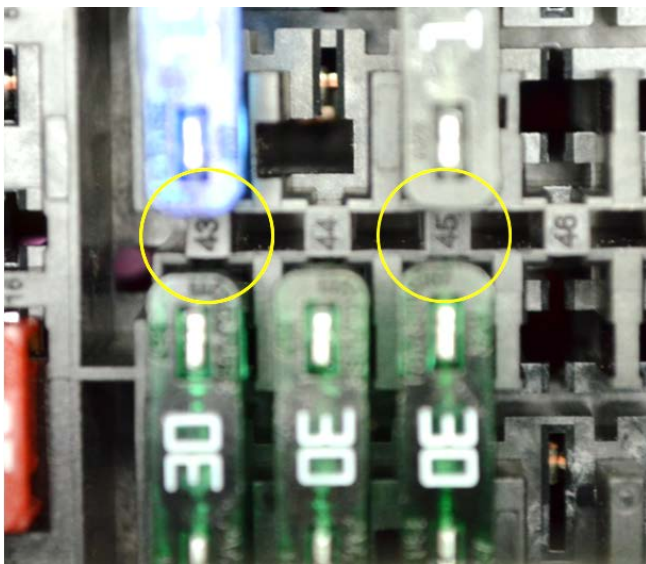
- Before beginning disassembly, FUSES for door control units (window motors) **MUST BE REMOVED!**
- During removal of fuses, the front **DOORS MUST BE OPEN!**
- The Adhesive **MUST** cure for three (3) hours before windows are operated. During this time, windows **MUST NOT MOVE!**
- Fuses may **ONLY** be installed **AFTER** the three (3) hour cure time.

- ⇐ Access the Fuse panel C (driver side, behind glove compartment) and remove the two fuses SC43 and SC45 <arrows> for door control units (window motors).

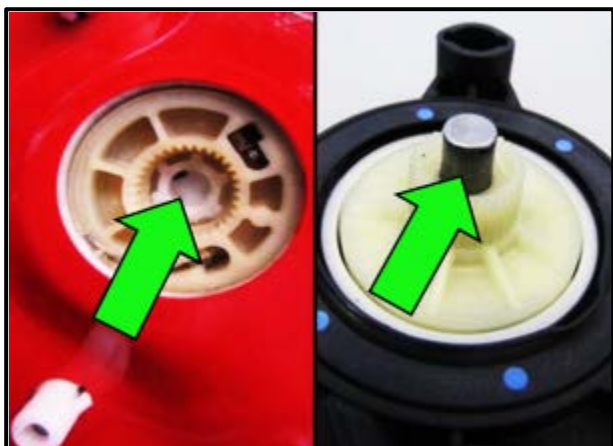
If regulator gear drum unseats or comes out too far, damage to regulator may occur.

- ⇐ Using a lint-free cloth and the blade of a screwdriver, wipe excess grease from the centering hole in the regulator <left arrow>.

- ⇐ Using lint-free cloth, clean any excess grease from window motor shaft <right arrow>.

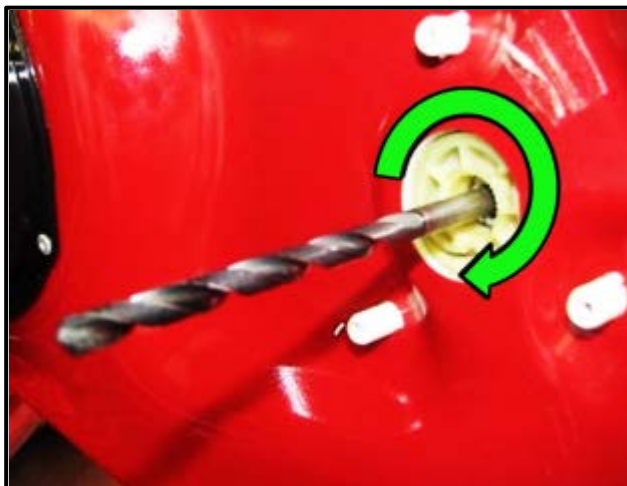
**CAUTION:** It is important that the adhesive remains only in the regulator bore and does not leak out onto the gear splines. Do not allow adhesive to come in contact with the regulator gear splines.

- ⇐ Using the back side of an 8mm drill bit, lightly insert and rotate drill bit in order to evenly spread the adhesive in the regulator bore inner wall.

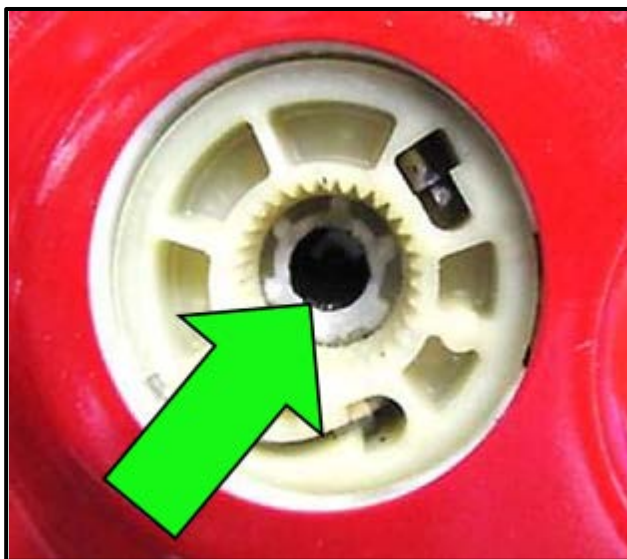
**CAUTION:** It is important that the adhesive remains only in the regulator bore and does not leak out onto the gear splines. Do not allow adhesive to come in contact with the regulator gear splines.

- ⇐ Place another large drop of adhesive part number (D 195 800 A1) as shown <arrow> into the lower corner of the regulator bore.
