Date 1.2013 Group **371** No. **042** Release **02** Page 1(6)

Jumper Harness, Repair  
VN, VHD, VT, VAH

## FSB 371-042, Jumper Harness, Repair

On some Volvo trucks built between January 2010 and May 2012, the front chassis to chassis extension harness connector may not seal properly. This may lead to corrosion which can cause ABS faults. New service jumpers have been released, and should be used to replace the existing connector if corrosion occurs.

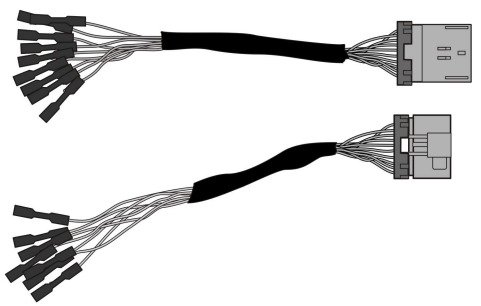
| <p><b>Black female with 14 wires with splices – 21945719</b><br/><b>Black male with 14 wires with splices – 21945721</b></p> | <p><b>Harness Repair Tape 20469544</b></p> |
