# Service Bulletin

**Subject:** Hydraulic Pump Leaking Fluid in Area of Rear Seat, Floor or Trunk, Convertible Top Inoperative or Noise

**Models:** 2011-2014 Camaro Convertible

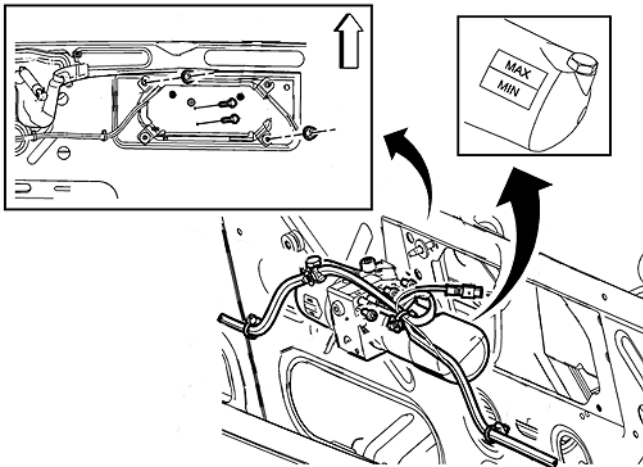
The cause of this condition may be that the fluid reservoir on the pump was either improperly installed at the supplier or knocked out of position during installation to the vehicle and is leaking oil.

2. Inspect the fluid reservoir for correct installation/position on the pump assembly. The graphic above shows an example of the reservoir tipped and not properly seated, which exposes a gap where fluid can leak.

**Important:** When fully seating the reservoir, make sure the original position of the reservoir and the retaining clamp is maintained and that neither is rotated in relation to the pump.

3. Loosen the retaining clamp screw and fully seat the reservoir to the pump. Re-tighten the clamp screw.
