CANADA, UNITED STATES, MEXICO Document ID: IK0900075 Countries: Availability: 1212 Revision: Major System: COOLING Created: 11/19/2012 Last Modified: 10/16/2013 Current Language: English Other Languages: NONE Author: Thomas Hoffmeister

Title: Horton Stratis Fan Hub Diagnostics

Applies To: Prostar, LoneStar, TranStar, WorkStar, IBB

Horton VMaster Ultra (Stratis) Viscous Fan Drive Troubleshooting Guide Engine feature code 12THX

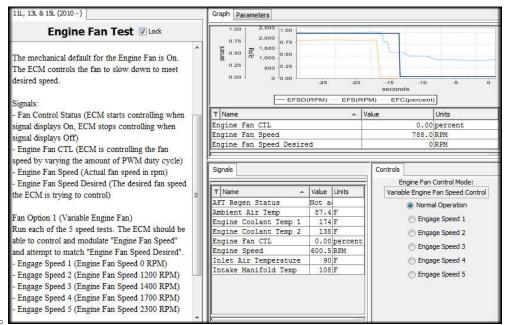
4. Engine Fan Test Results

- o You will need to monitor the entire fan test while it is running to determine if the fan has passed or failed.
- o The fan needs to operate within the limits at each test point. The fan should engage and remain engaged during the entire engagement request.
- The actual fan speed should be approx ± 250 RPM of desired. Some viscous properties of the fan hub may vary the results. See examples below.
- Notice in the chart below, when the engine ramps with 0 RPM desired fan speed, the fan does pick up some speed. This is normal due to the
 viscous properties of the fan hub.
- Also as Îtem 3 points out, the engine speed and desired fan speed nearly match. If the fan is requested on 100%, the fan may actually engage at 125% of engine speed as shown.

The "Test Completed, Successful" window at the conclusion of the test does not indicate the fan has passed. It only indicates the test has been
completed successfully. You will need to determine if the fan has passed or failed.
